INSPECTION REPORT

AERIAL PRODUCTION SERVICES

Report Name: Sample
Report Date: December 1, 2020
Contractor: Aerial Production Services

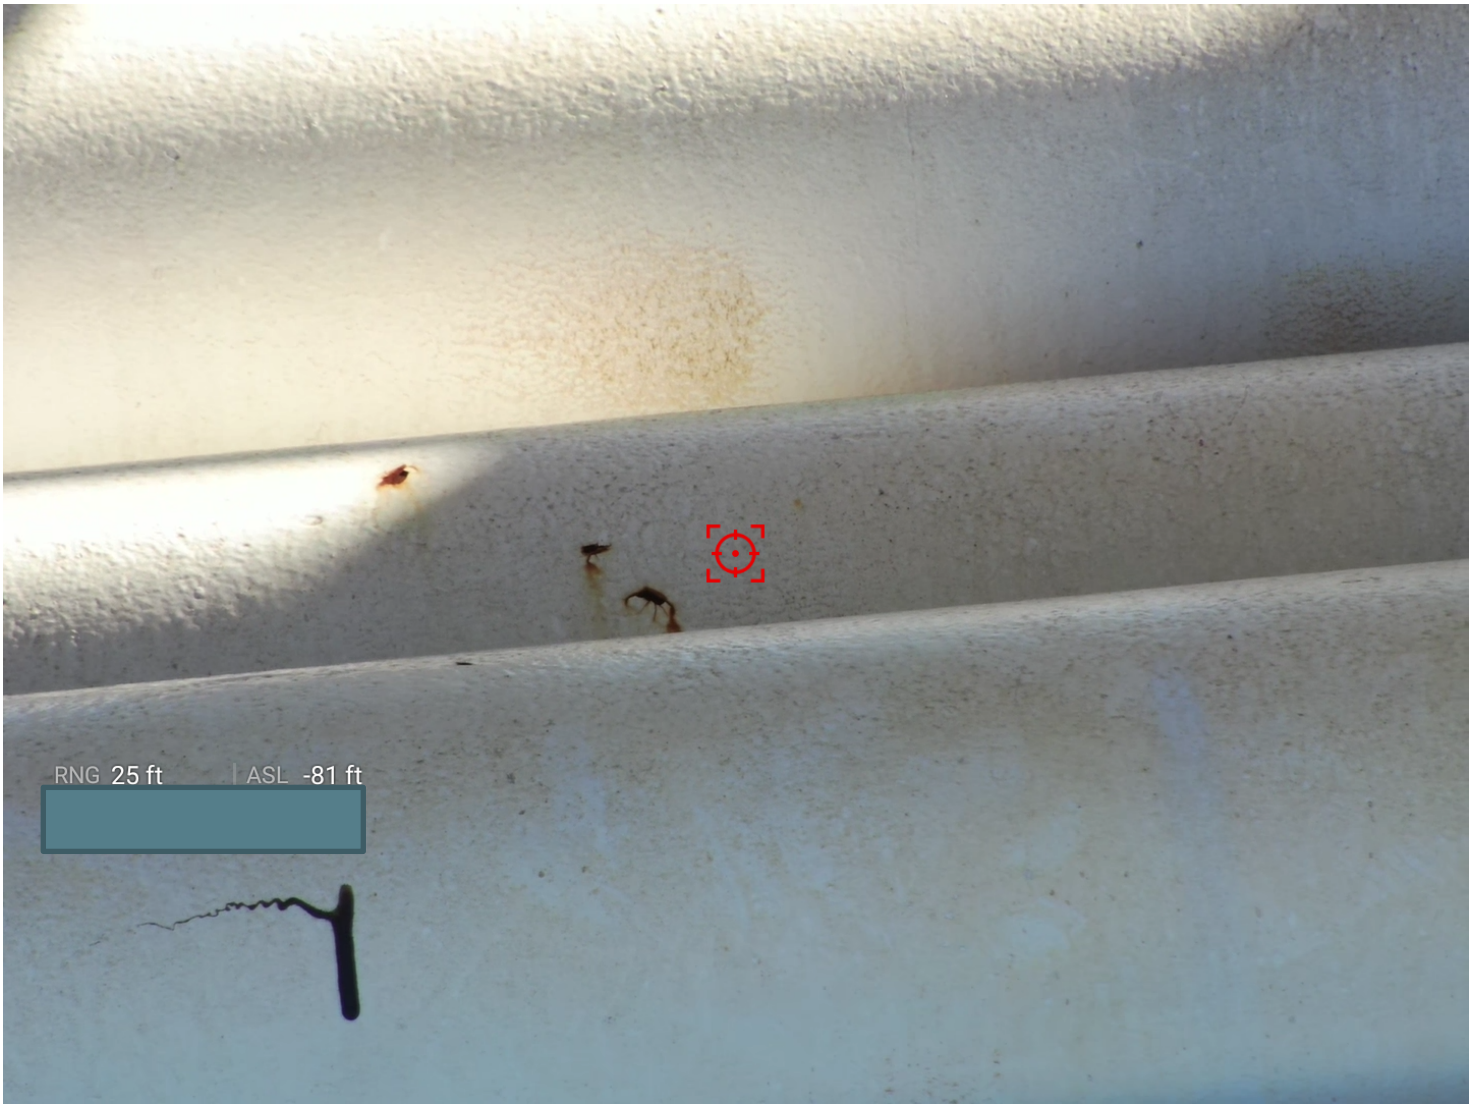
Time	Date	Location/GPS	Filename	Anomaly Type	Severity
10:17AM	12/09/2020		Liveviewshot_20130118-041328.png	Corrosion	Medium

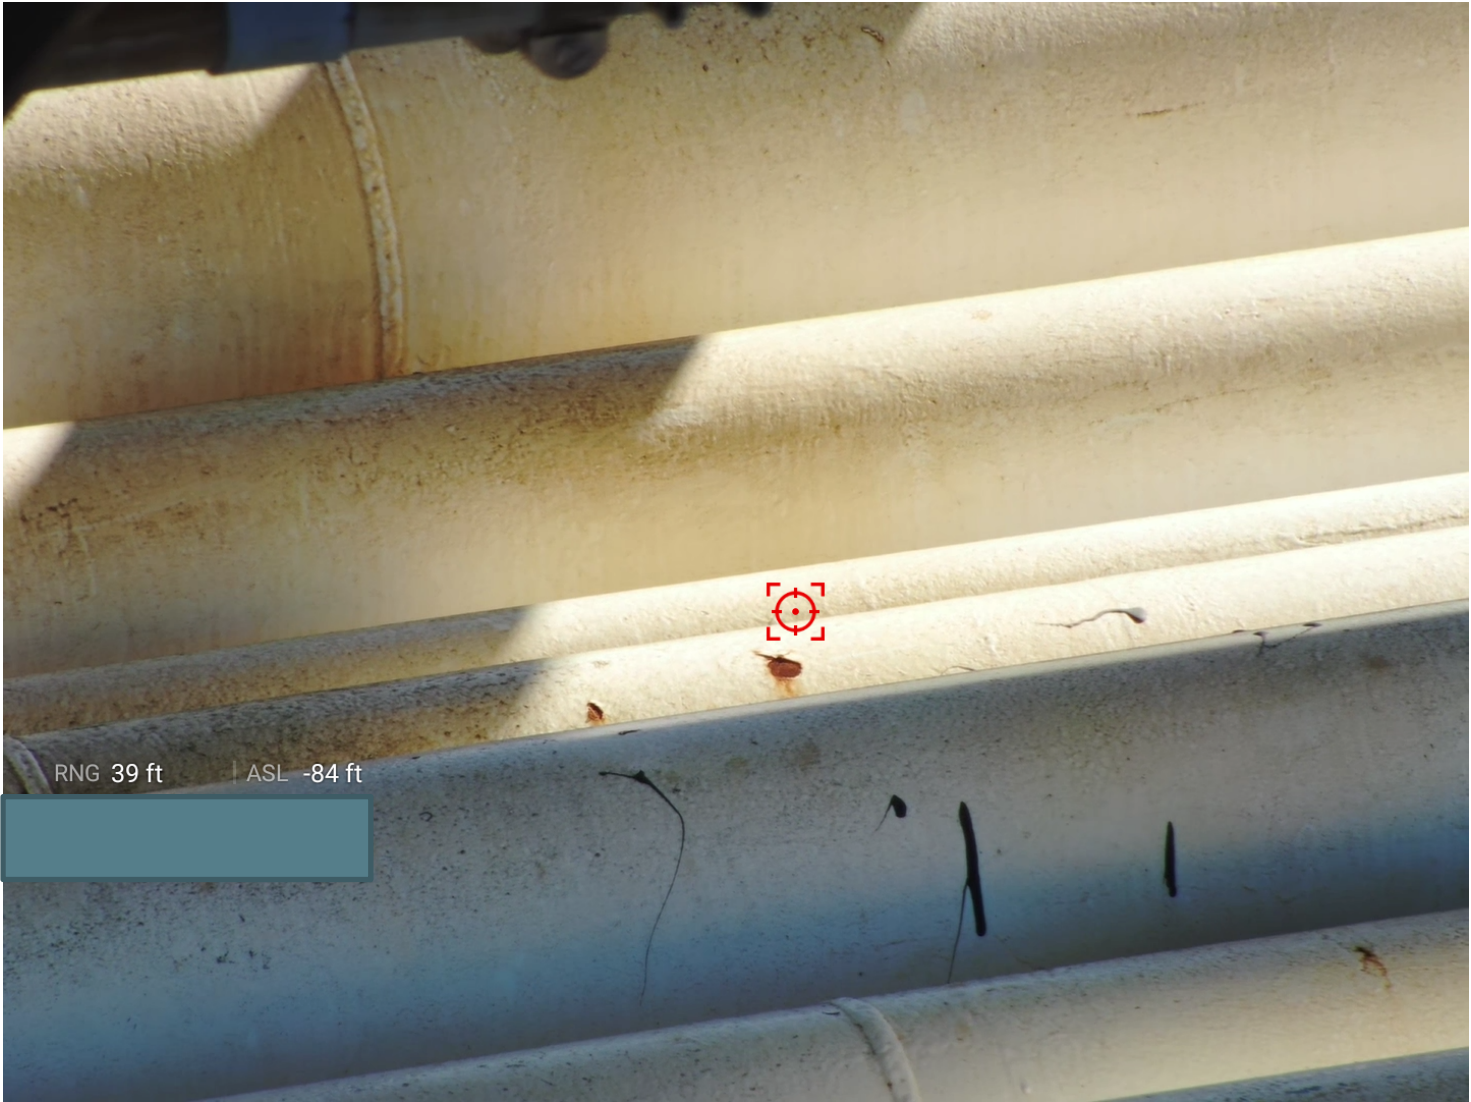
Time	Date	Location/GPS	Filename	Anomaly Type	Severity
10:20AM	12/09/2020	<div></div>	Liveviewshot_20130118-043421.png	Corrosion	Medium

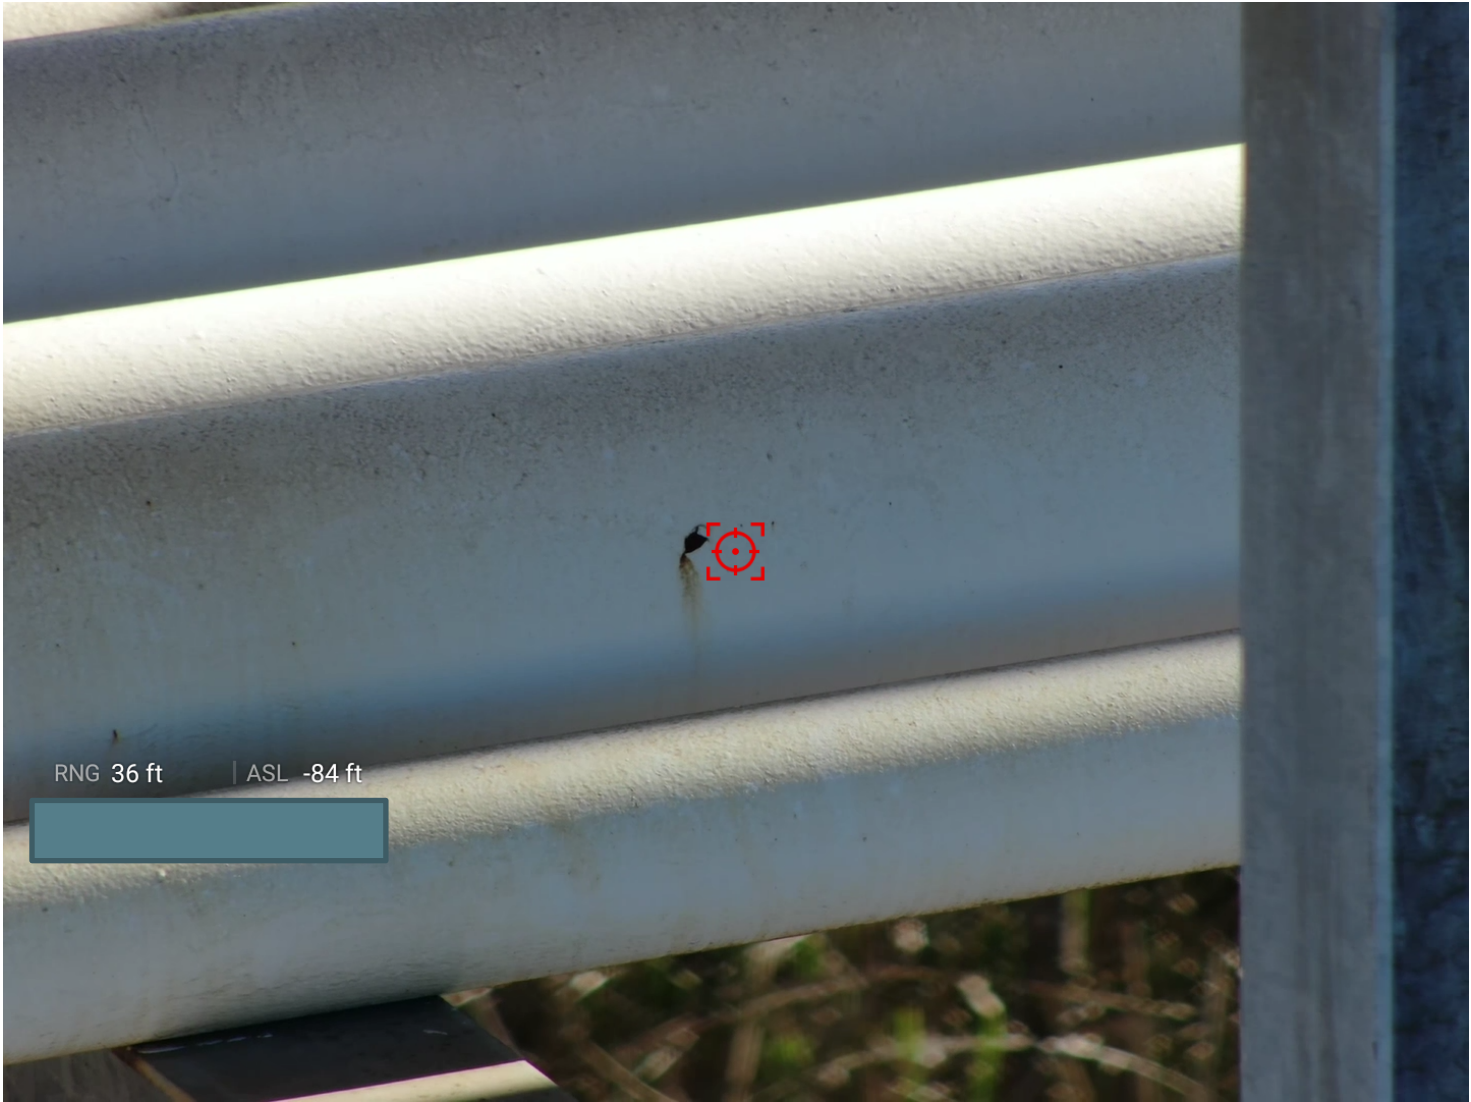
Time	Date	Location/GPS	Filename	Anomaly Type	Severity
10:22AM	12/09/2020	<div></div>	Liveviewshot_20130118-044220.png	Corrosion	Medium

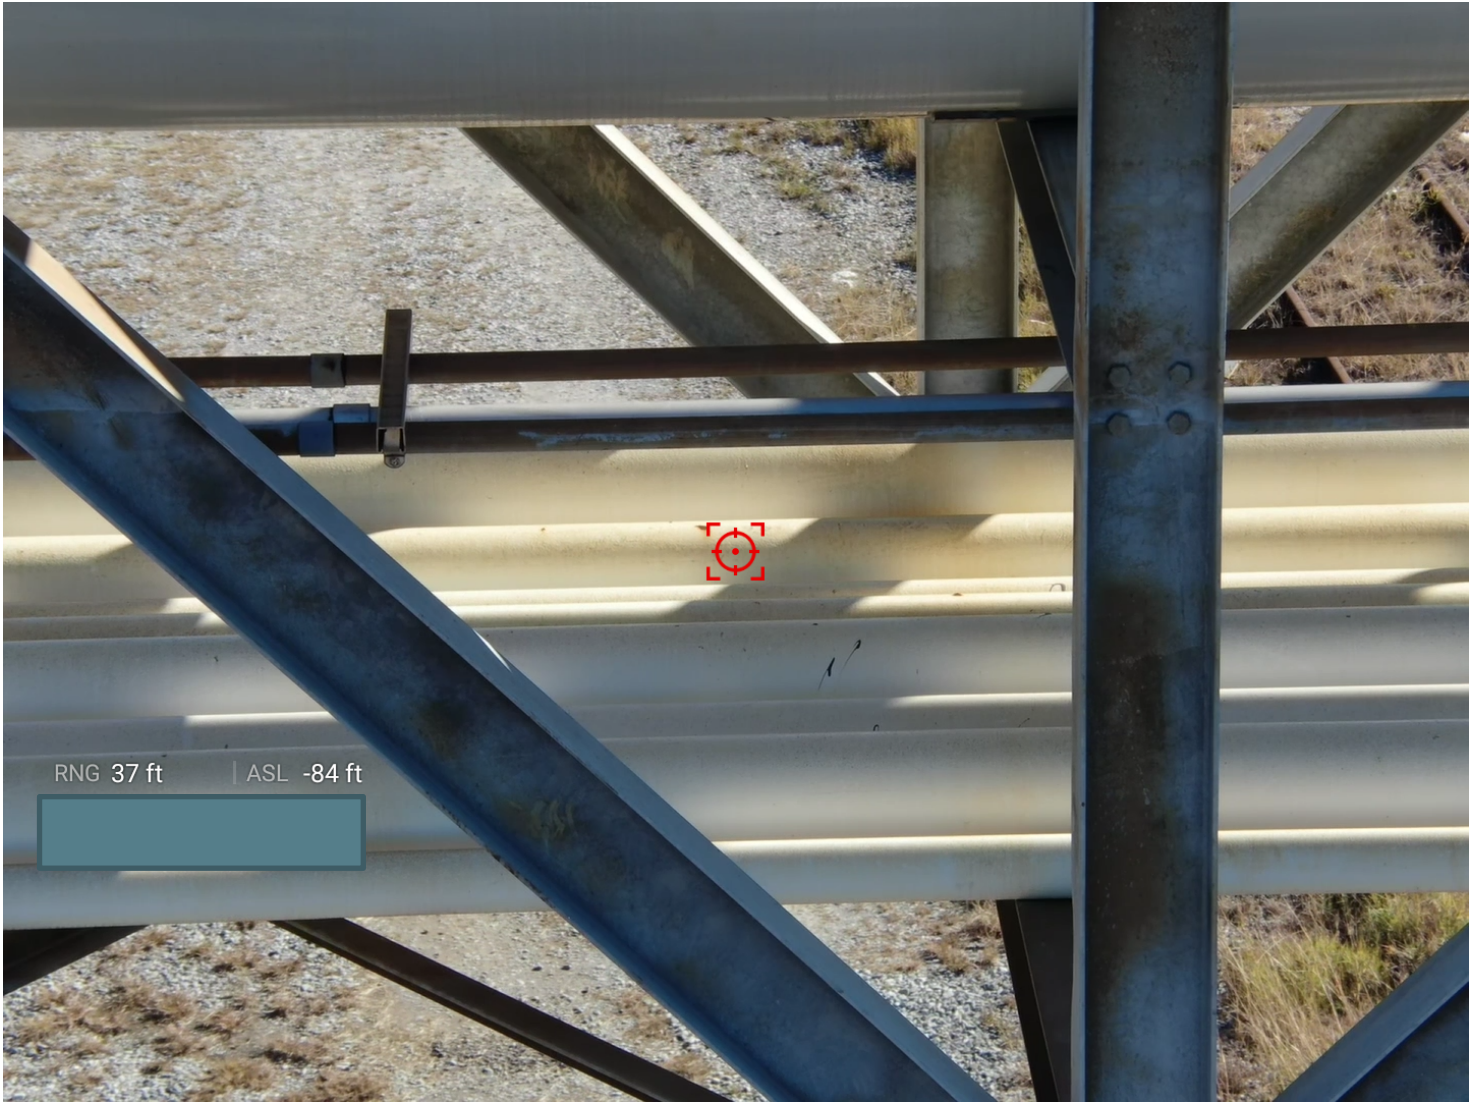
Time	Date	Location/GPS	Filename	Anomaly Type	Severity
10:25AM	12/09/2020	<div></div>	Liveviewshot_20130118-044536.png	Corrosion	Medium

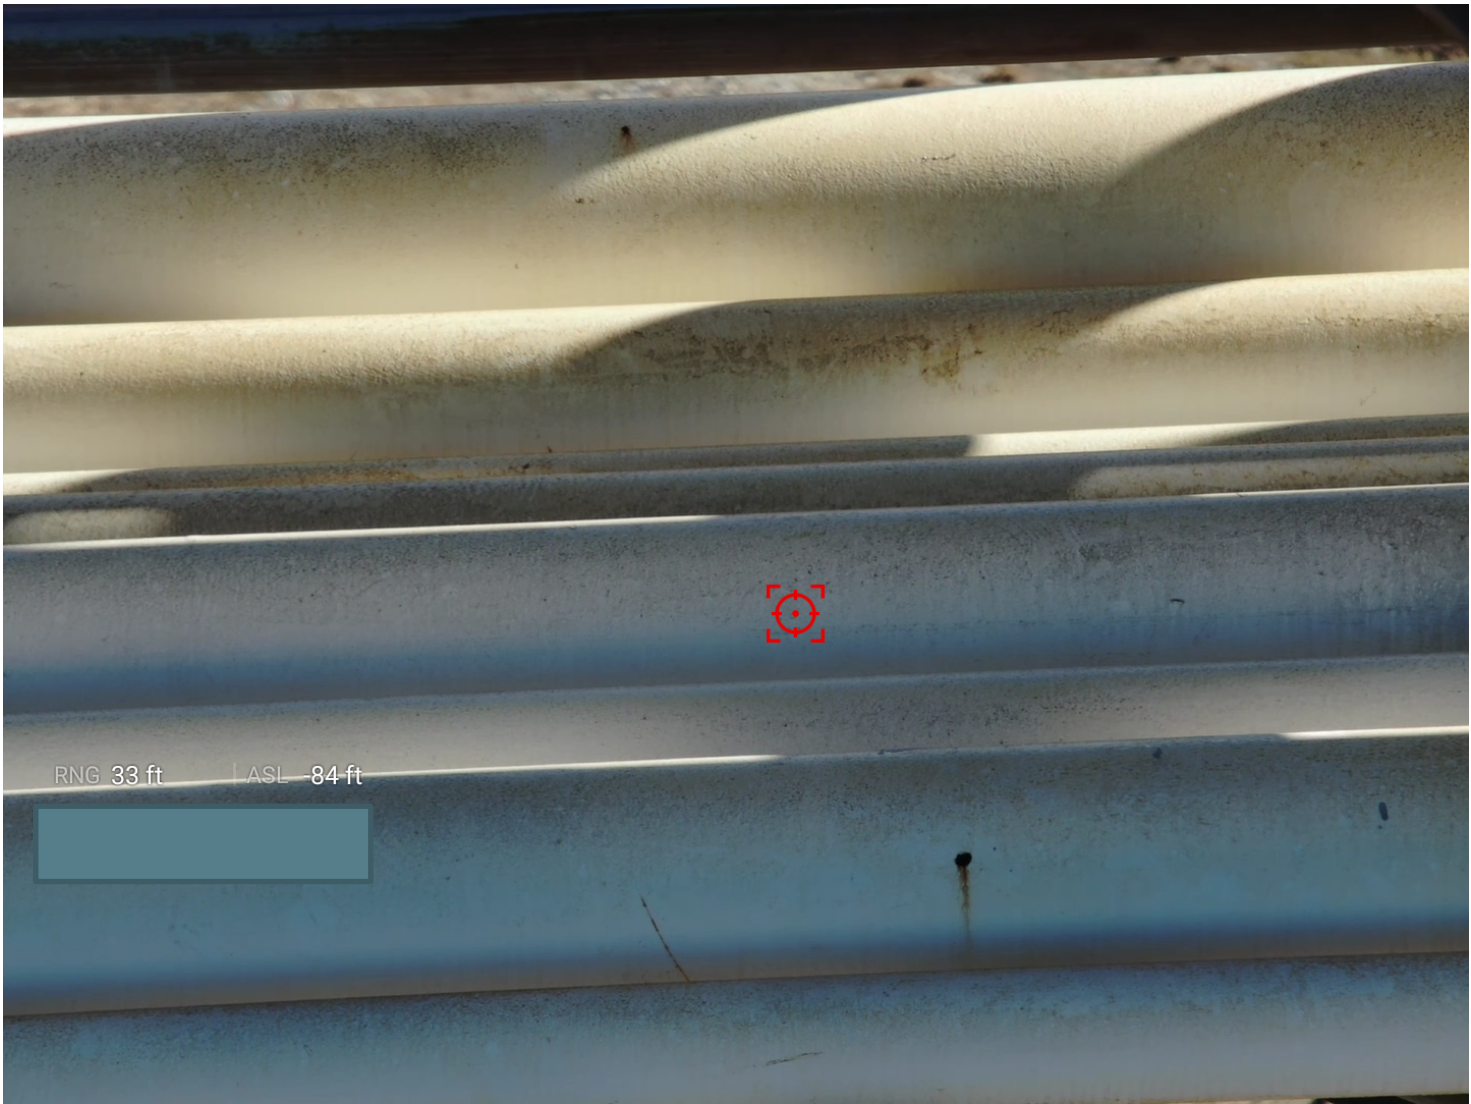
Time	Date	Location/GPS	Filename	Anomaly Type	Severity
10:28AM	12/09/2020	<div></div>	Liveviewshot_20130118-045624.png	Corrosion	Medium

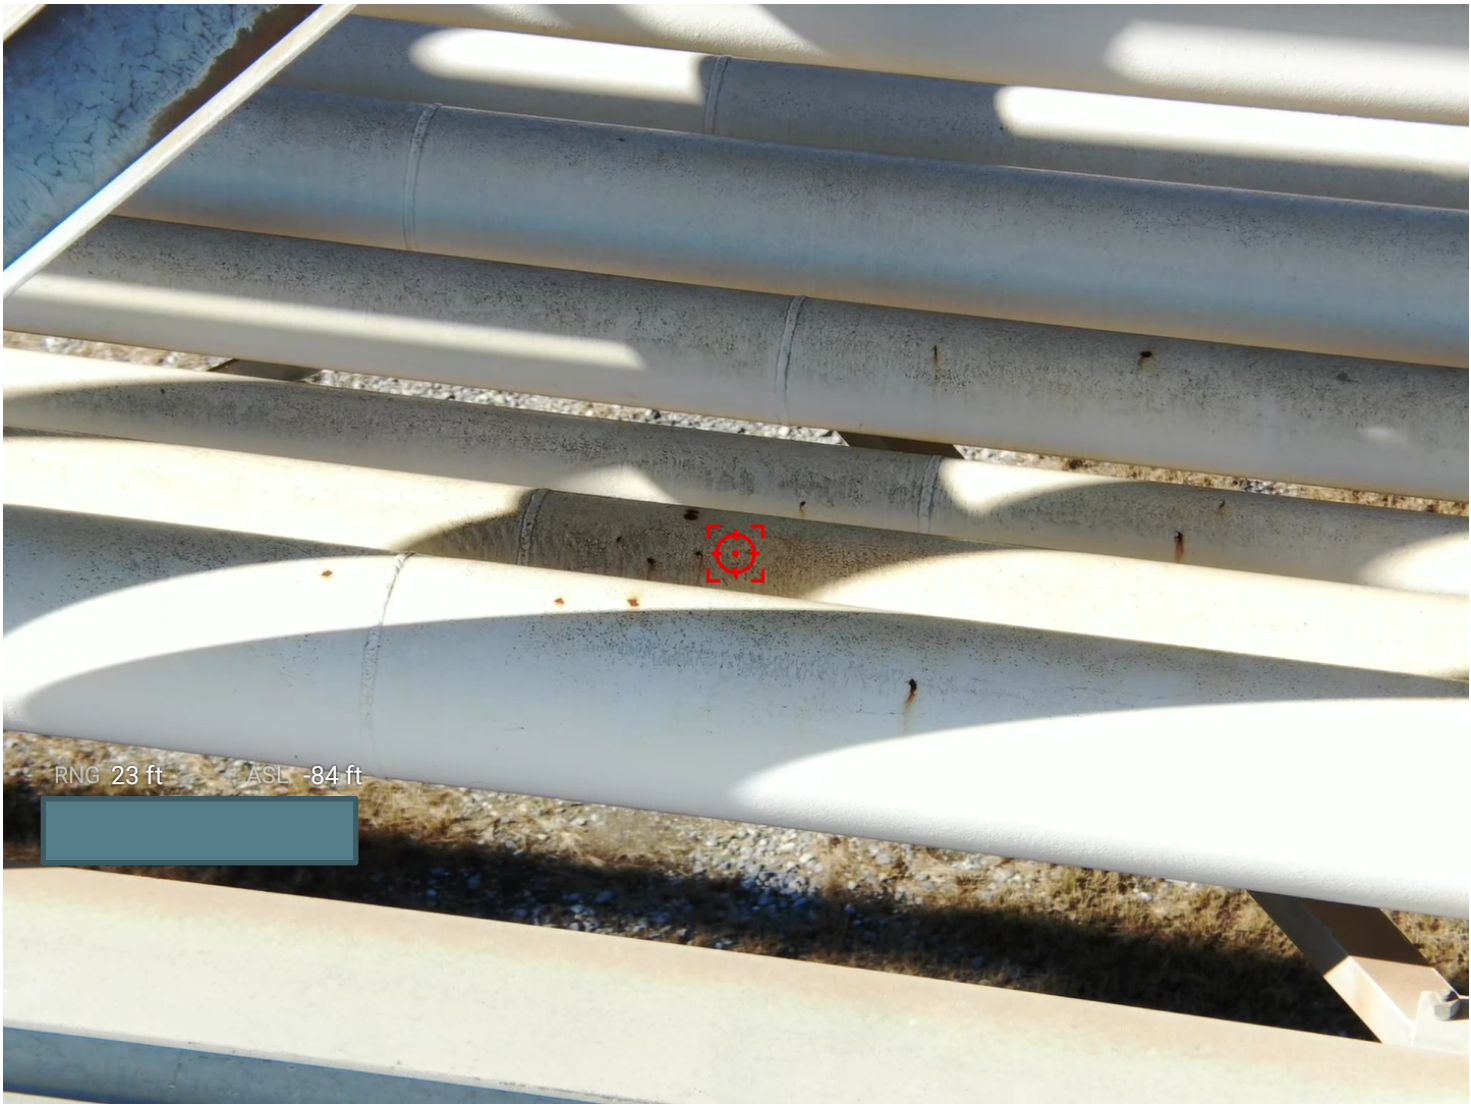
Time	Date	Location/GPS	Filename	Anomaly Type	Severity
10:30AM	12/09/2020		Liveviewshot_20130118-050628.png	Corrosion	Medium

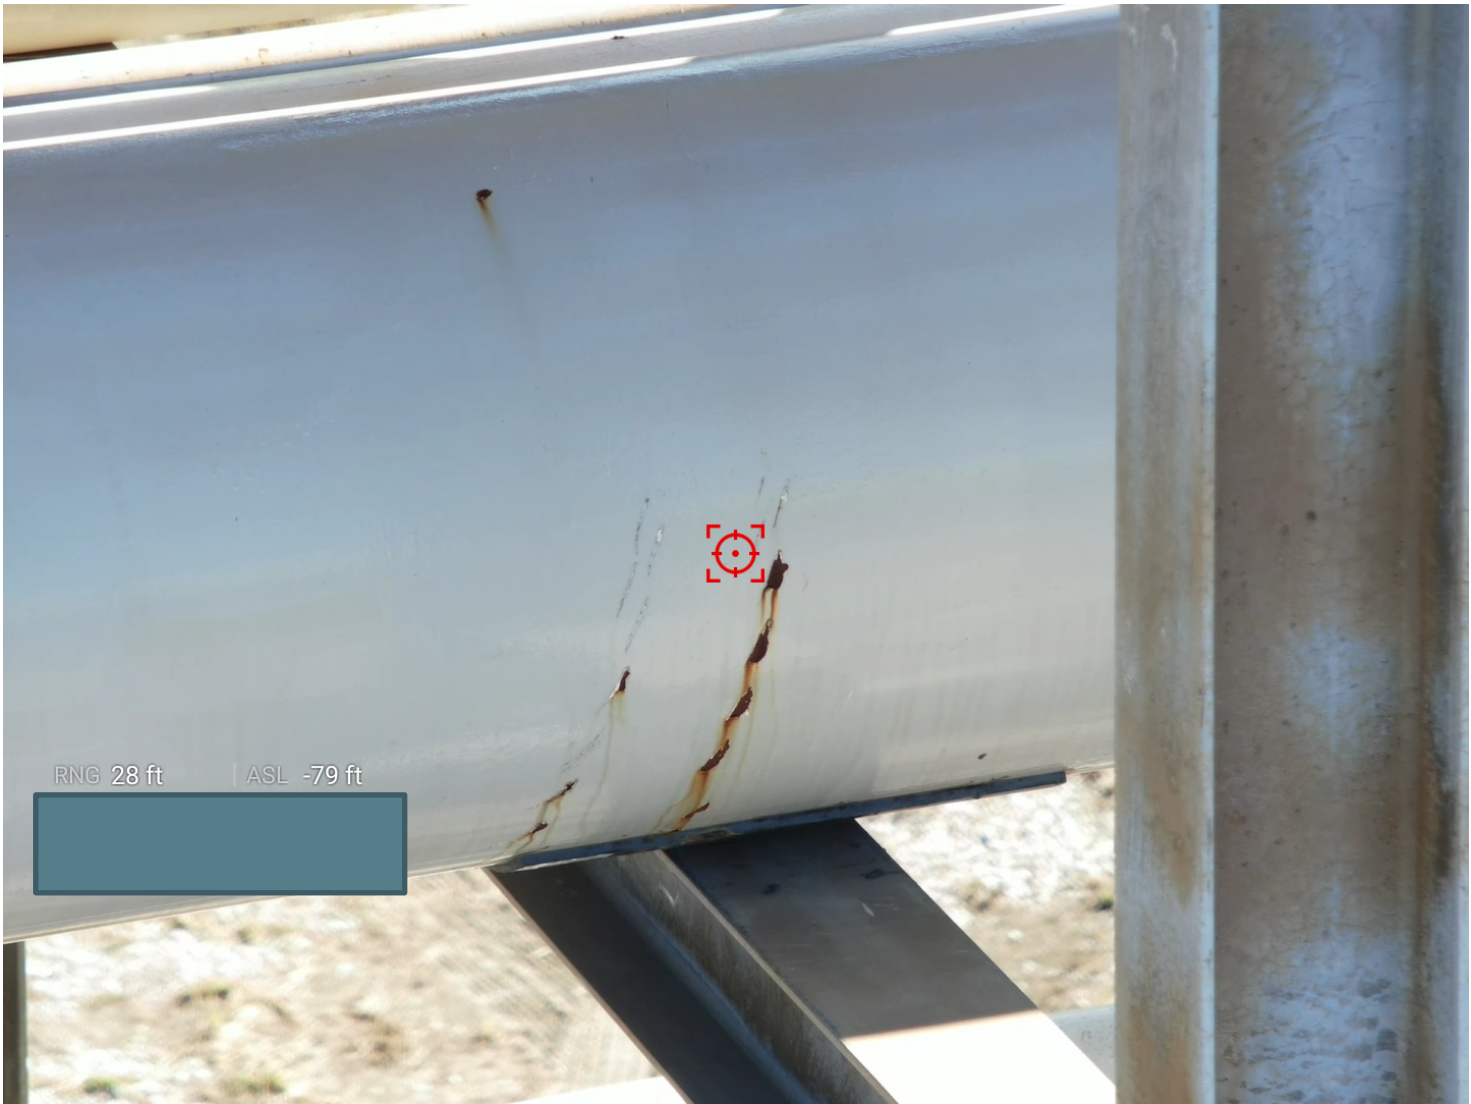
Time	Date	Location/GPS	Filename	Anomaly Type	Severity
10:47AM	12/09/2020	<div></div>	Liveviewshot_20130118-053421.png	Corrosion	Medium

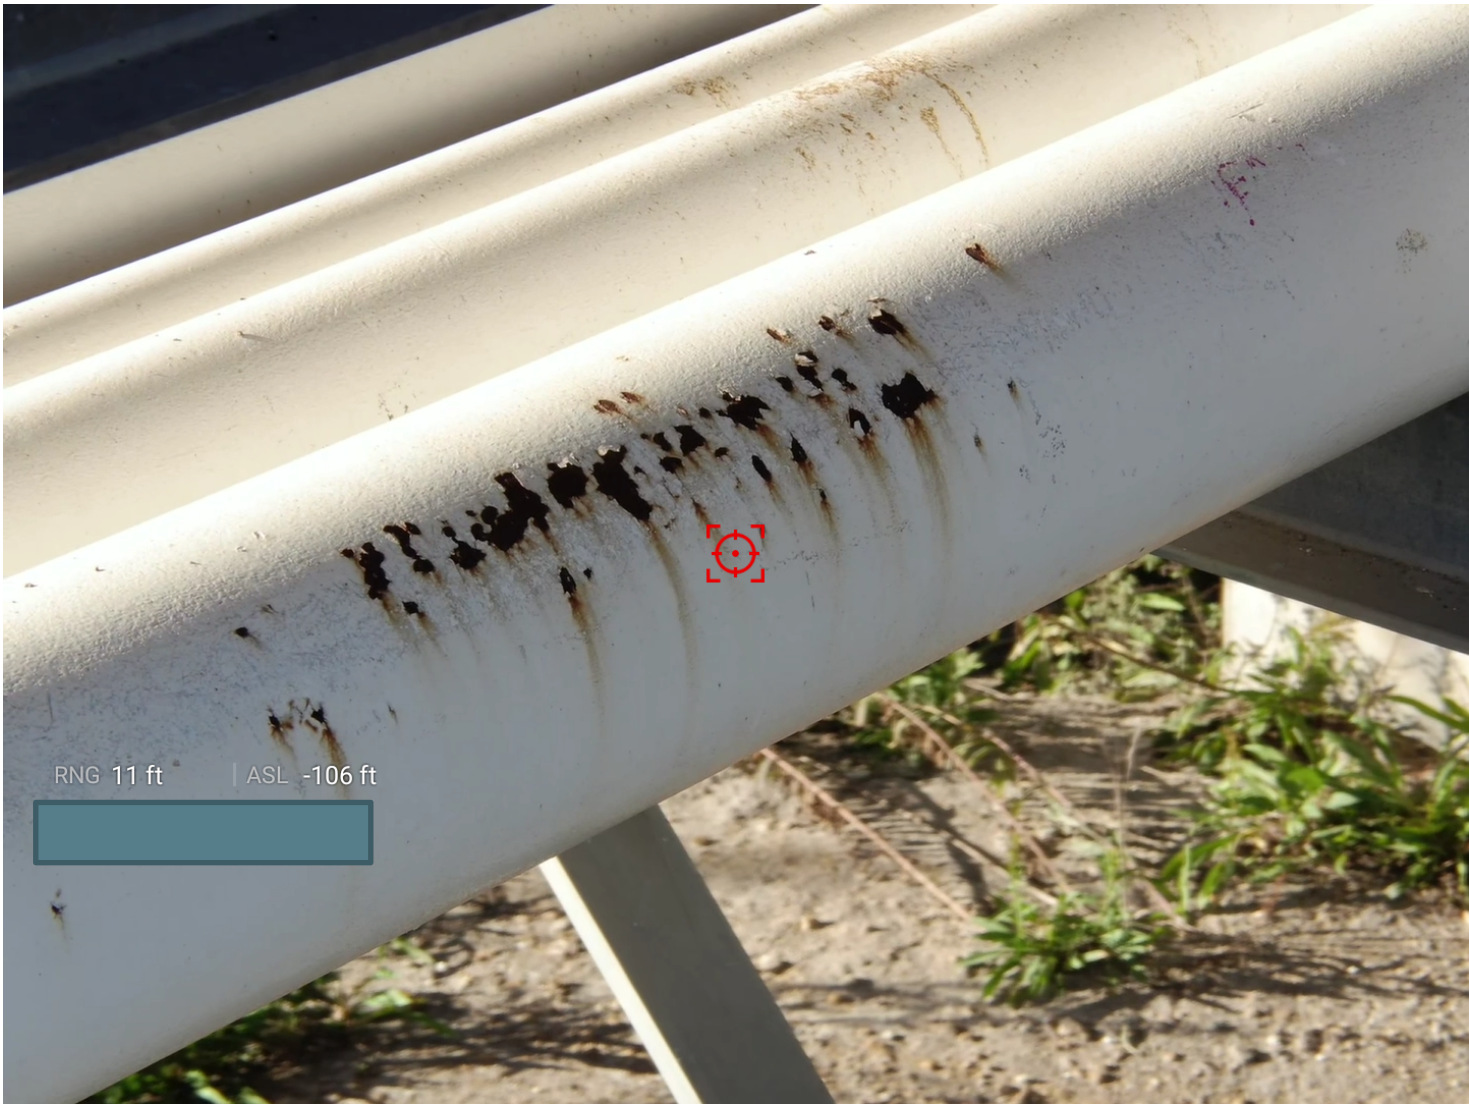
Time	Date	Location/GPS	Filename	Anomaly Type	Severity
11:33AM	12/09/2020		Liveviewshot_20130118-030142.png	Corrosion	Medium

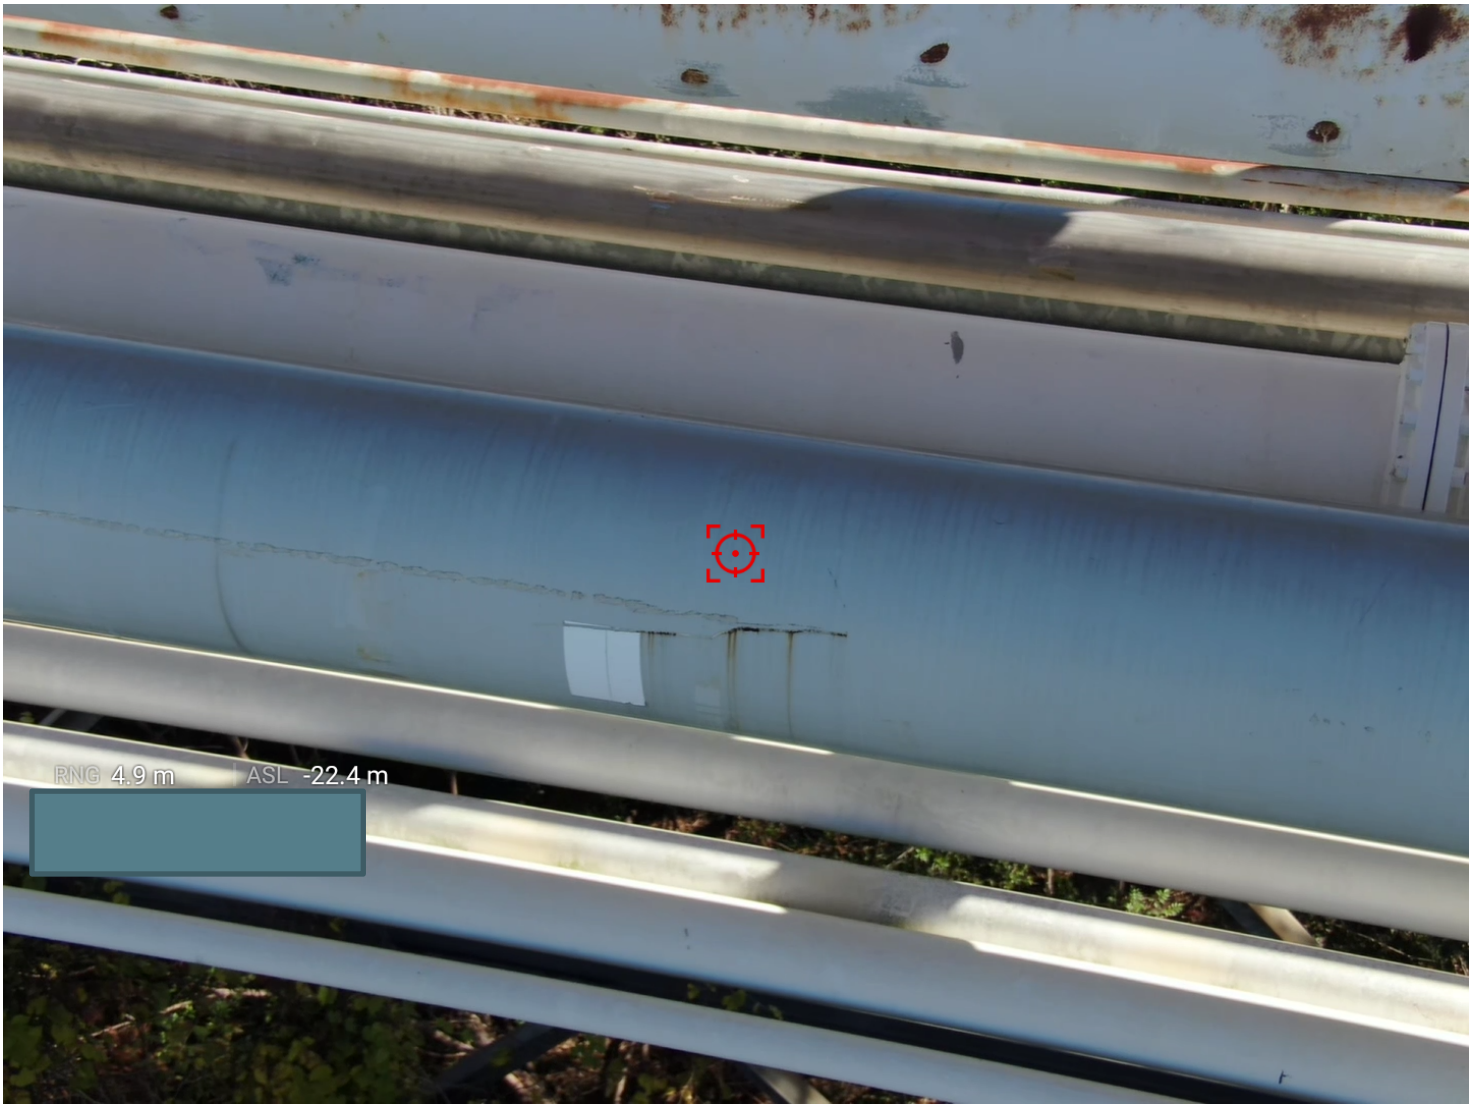
Time	Date	Location/GPS	Filename	Anomaly Type	Severity
11:25AM	12/10/2020		Liveviewshot_20201210-112013.png	Corrosion	Medium

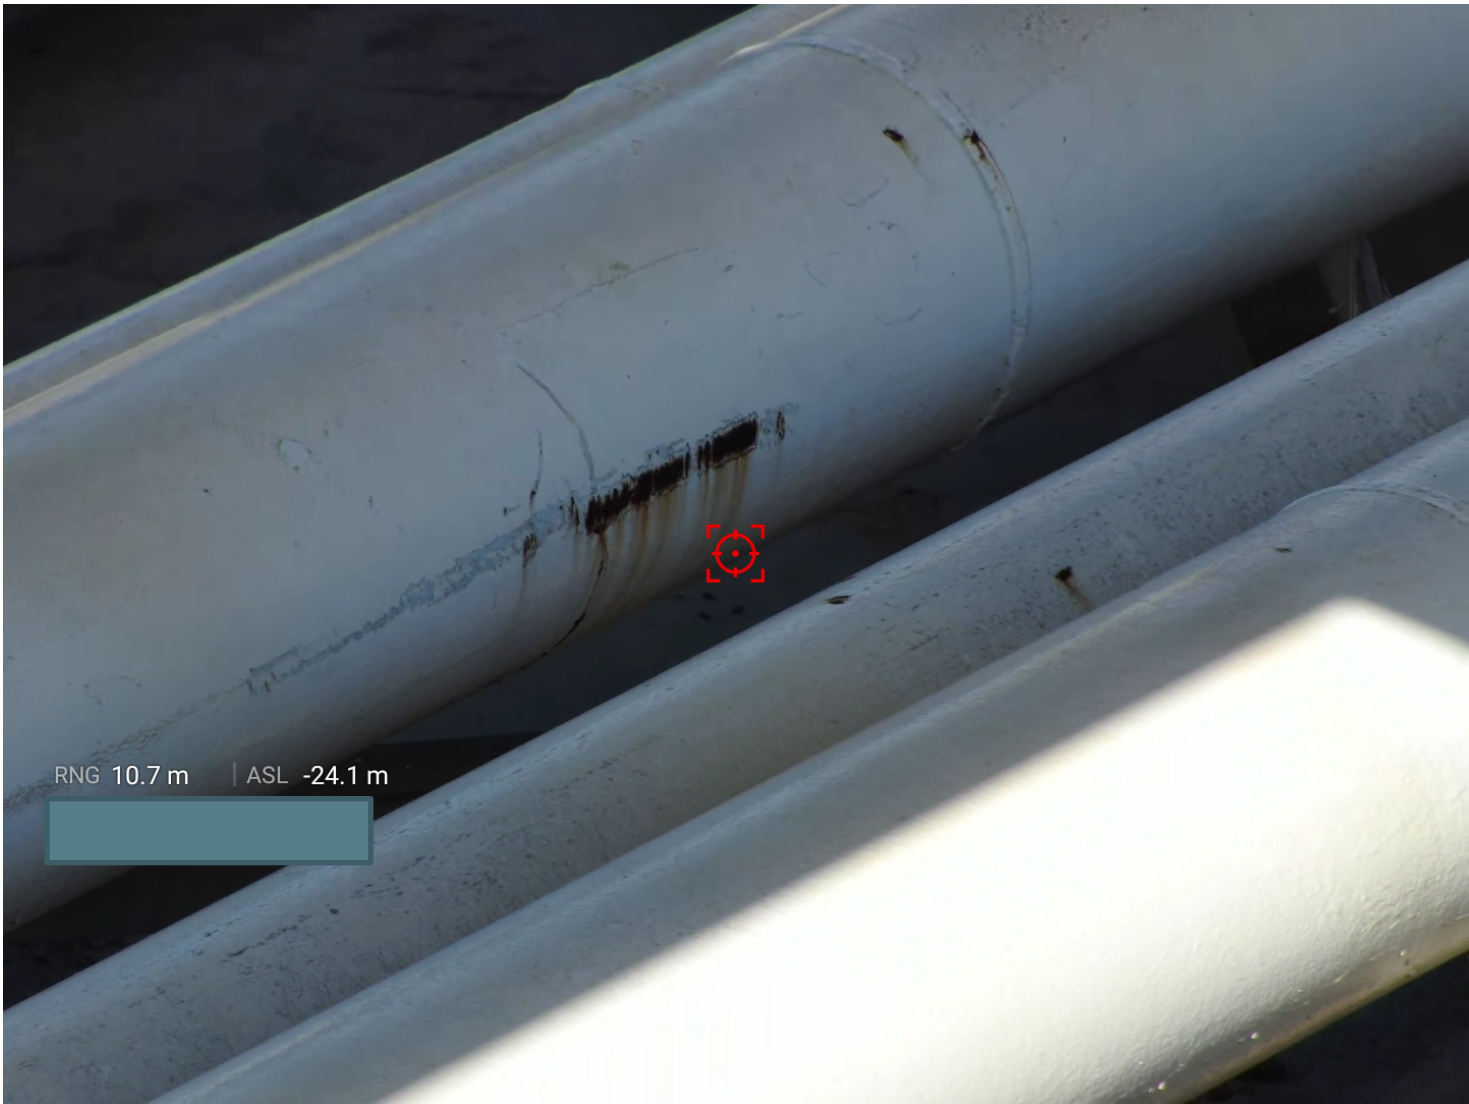
Time	Date	Location/GPS	Filename	Anomaly Type	Severity
12:07PM	12/10/2020	<div></div>	Liveviewshot_20201210-120730.png	Corrosion	Medium

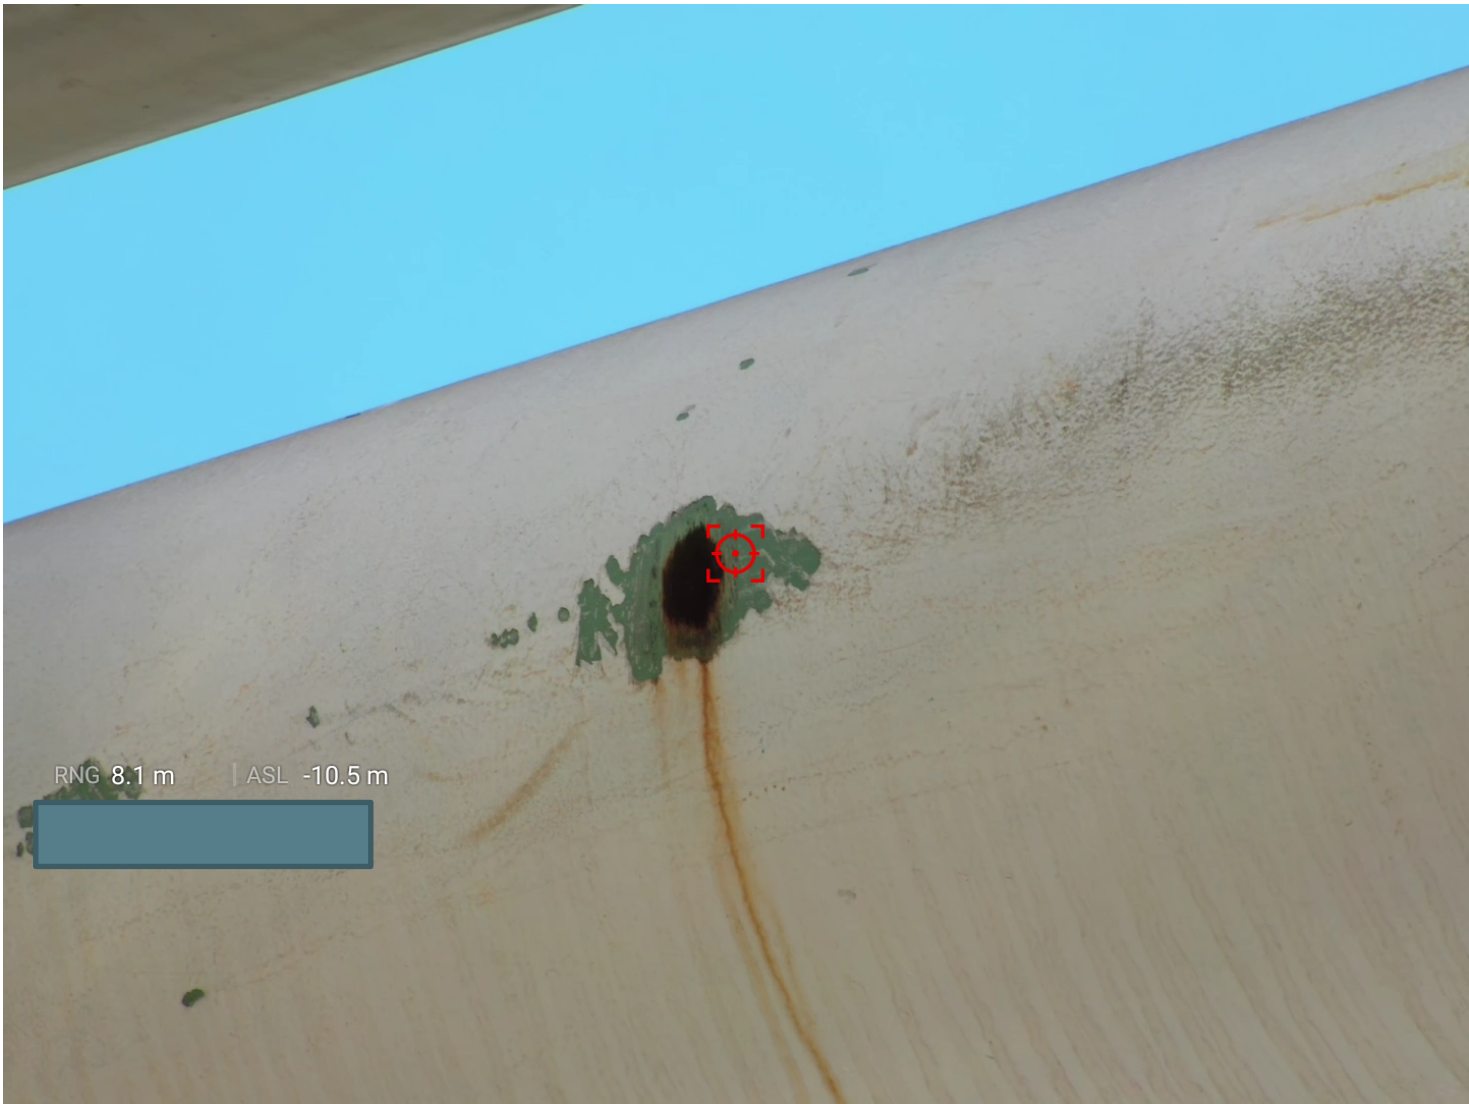
Time	Date	Location/GPS	Filename	Anomaly Type	Severity
1:12PM	12/10/2020	<div></div>	Liveviewshot_20201210-131155.png	Corrosion	Medium
