## SURVEY REPORT

## OVERVIEW

Aerial Production Services performed an Aerial Gas Leak Survey of [REDACTED] Compressor Station and 3 Well Site Locations Outlined in the Report. The Gas Leak Survey identified 9 Total Methane Leaks. See Report Below for additional Details.

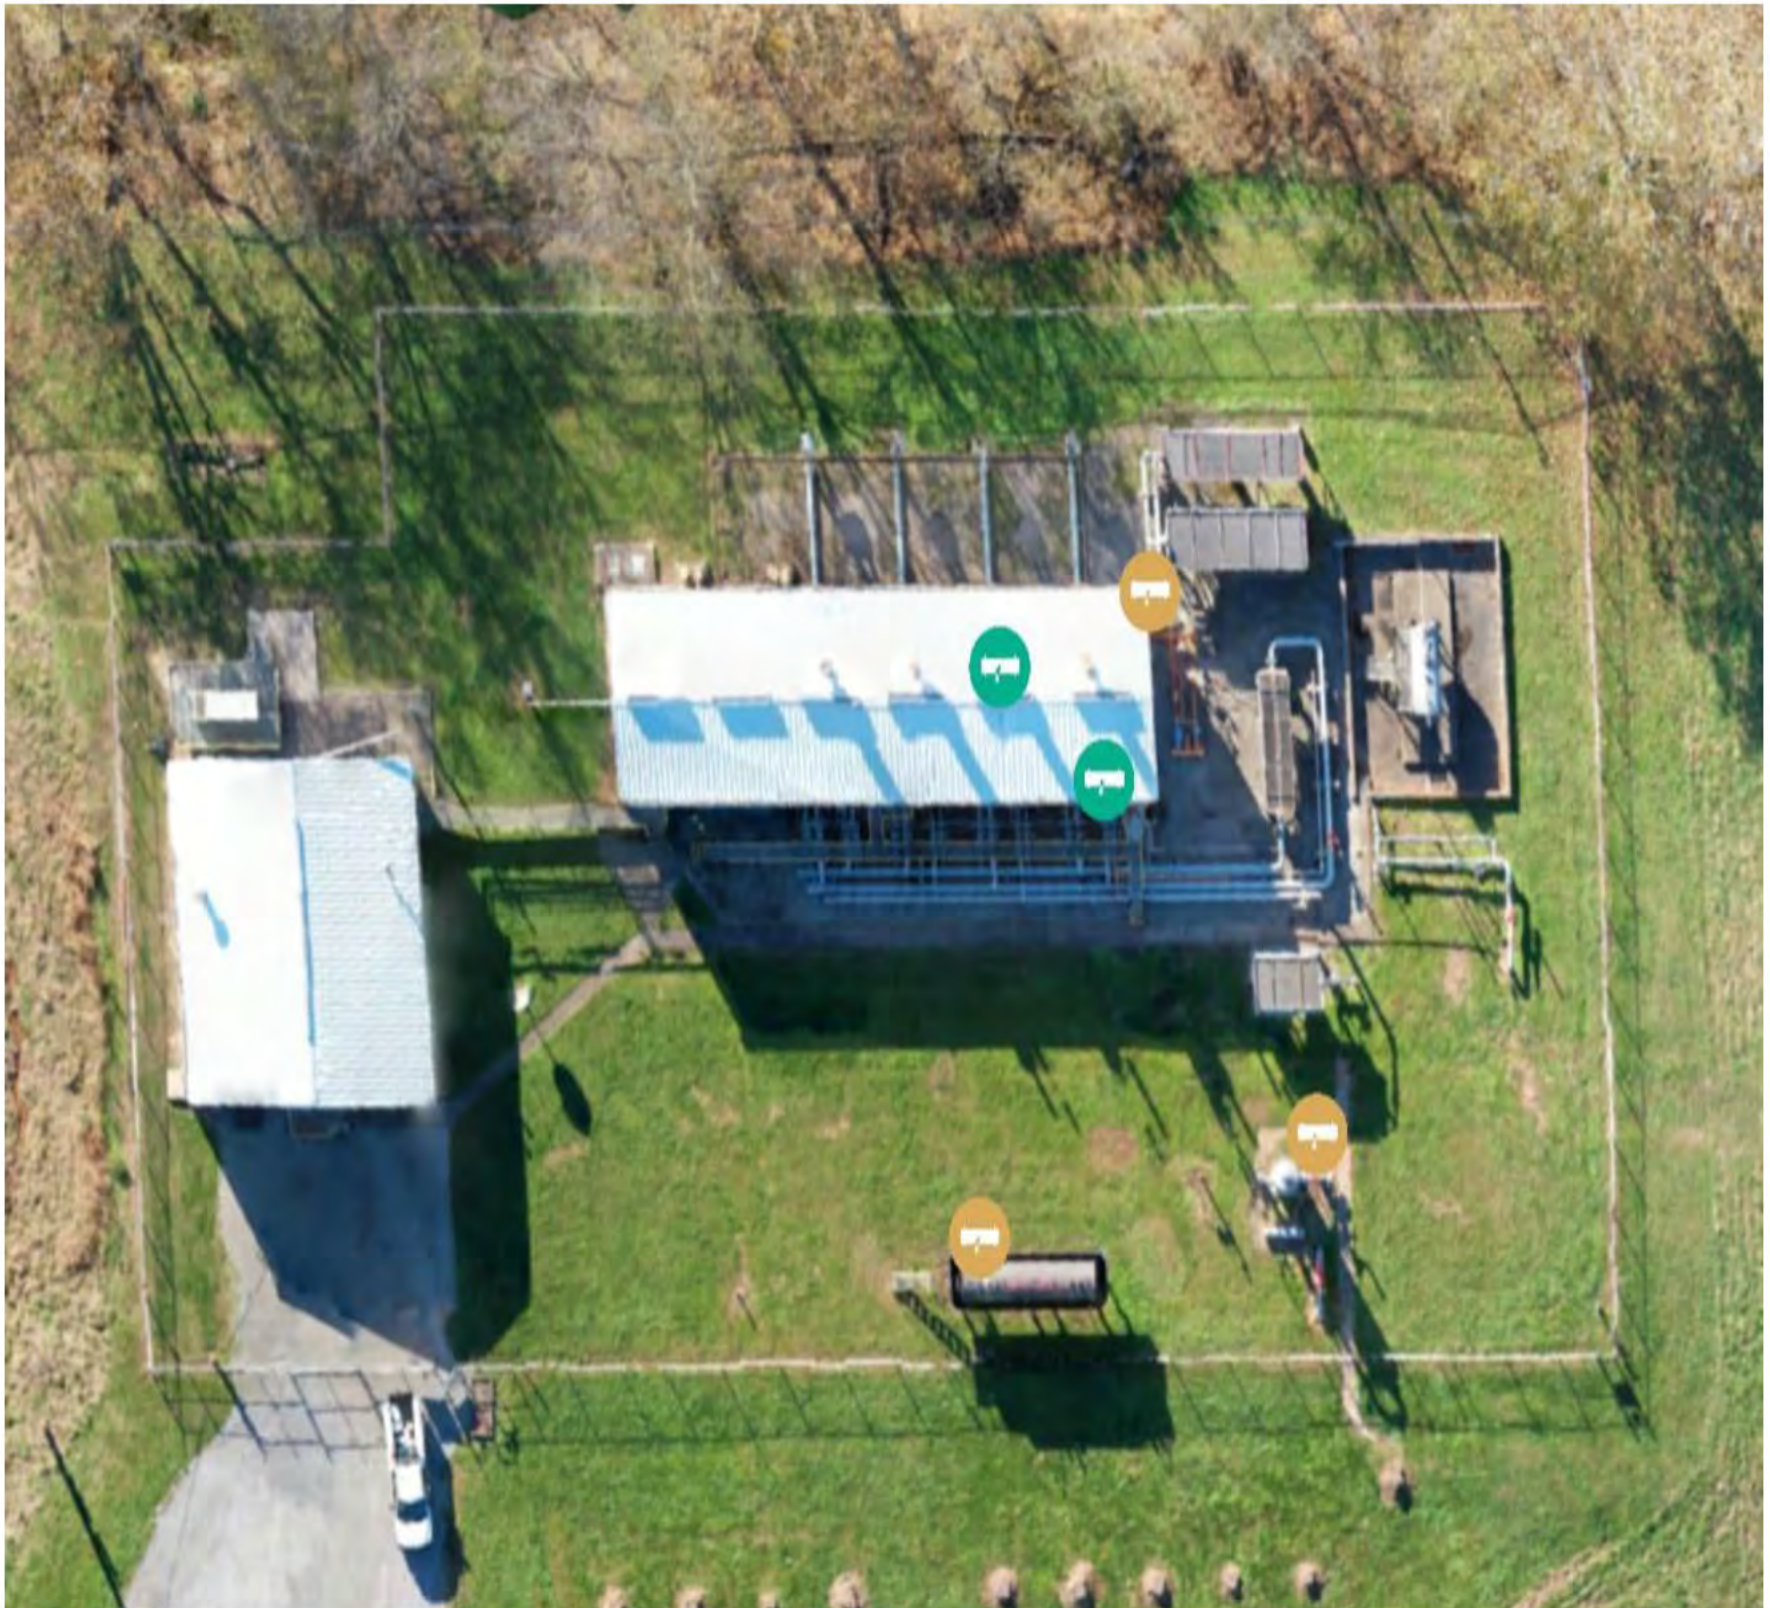
## Compressor Station Overview

Leak(s) Detected: 5

Leak 1: Condensate Tank. Consistent readings. Averaging approximately 3,000 ppm.m.

Leak 2: Separator. Consistent readings. Averaging 1,500 ppm.m

Leak 3: Unknown Equipment Type. Consistent readings. Averaging 2,300 ppm.m.

Leak 4: Exhaust Readings. Higher Methane readings within the area of the Compressor Exhaust. Saturating the area.

Leak 5: Unknown Equipment Type. Inconsistent readings. Very low readings. Sporadic.

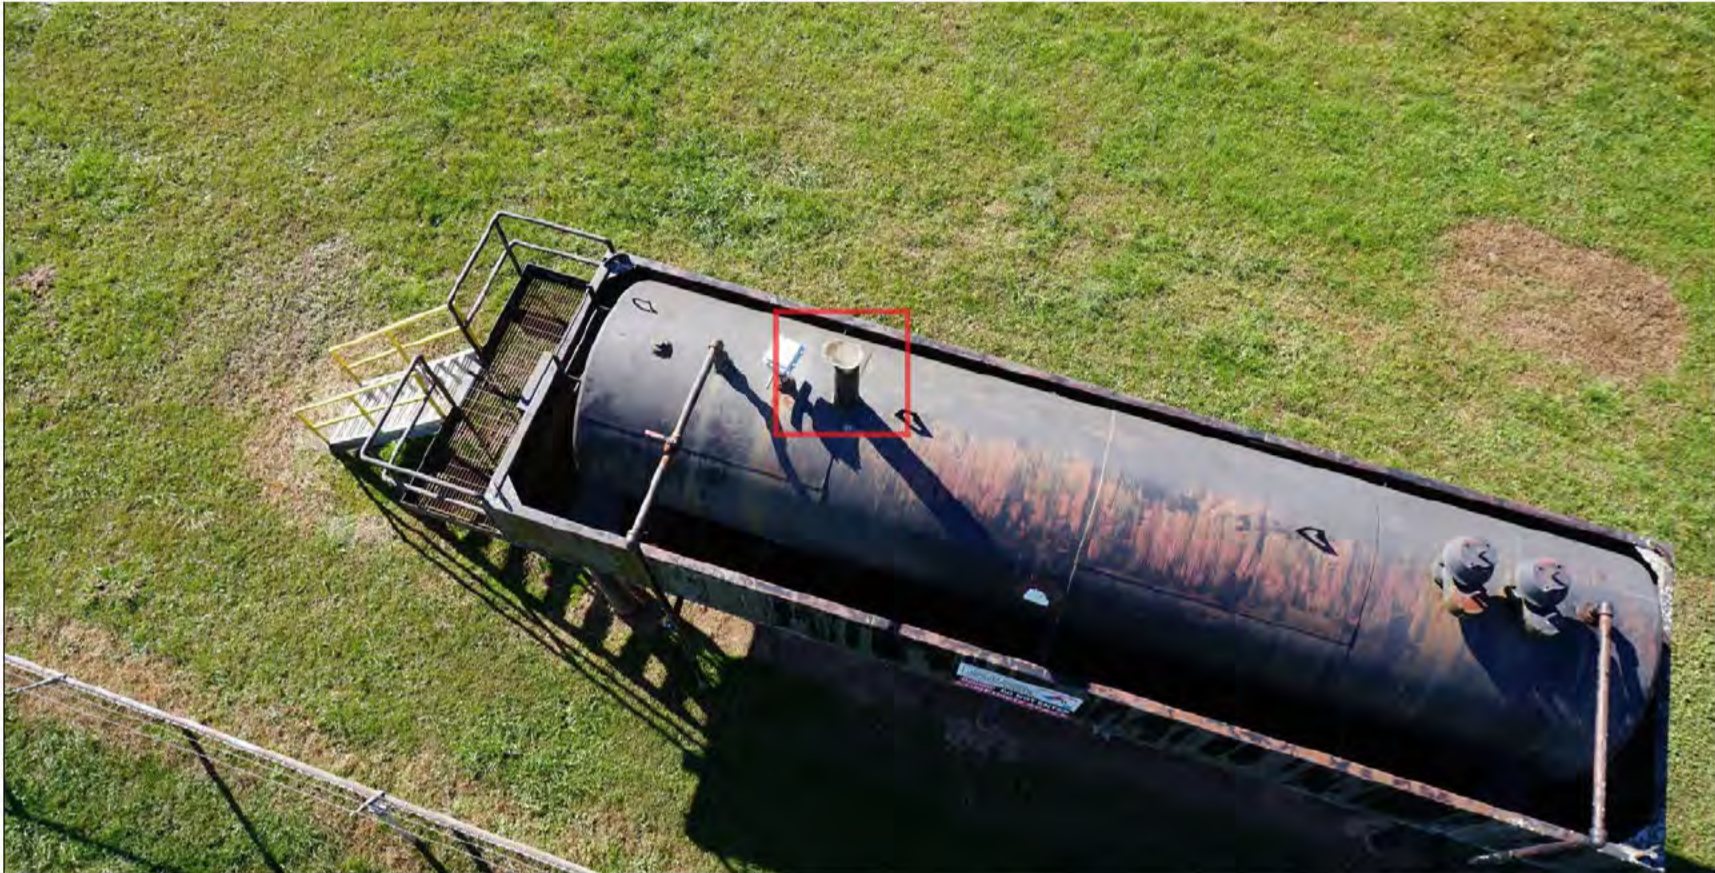
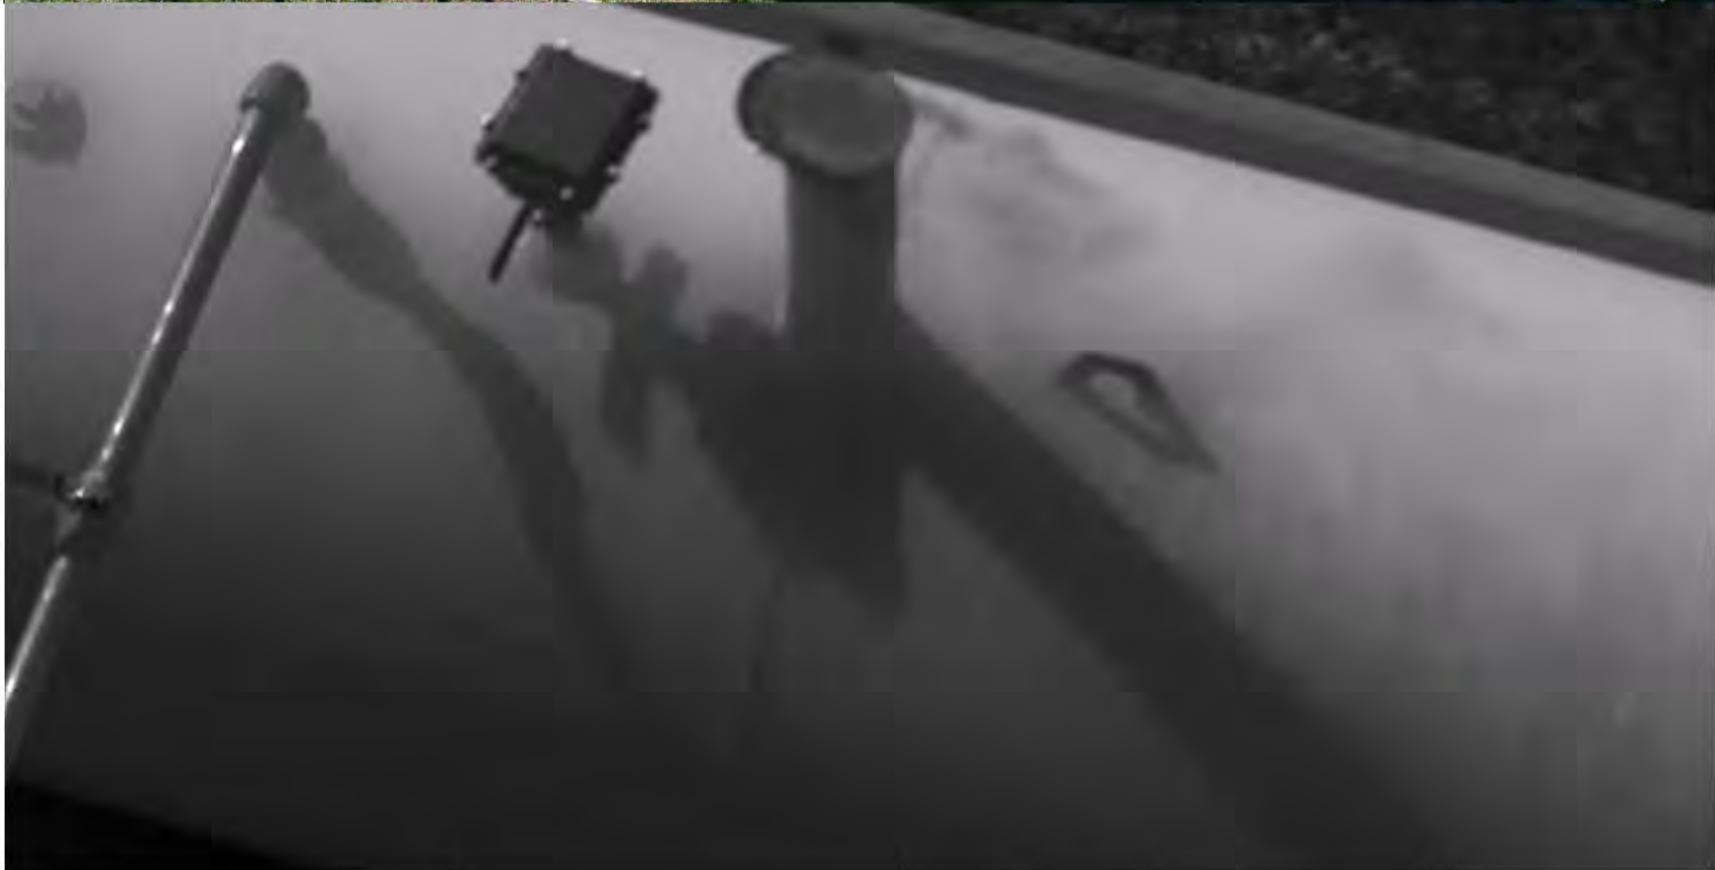
**Station Leak 1**

Time	Date	Location/GPS	Peak Reading (ppm.m)	Anomaly Type	Severity
11:27AM	11/07/2021	[REDACTED]	5432	Leak	Medium

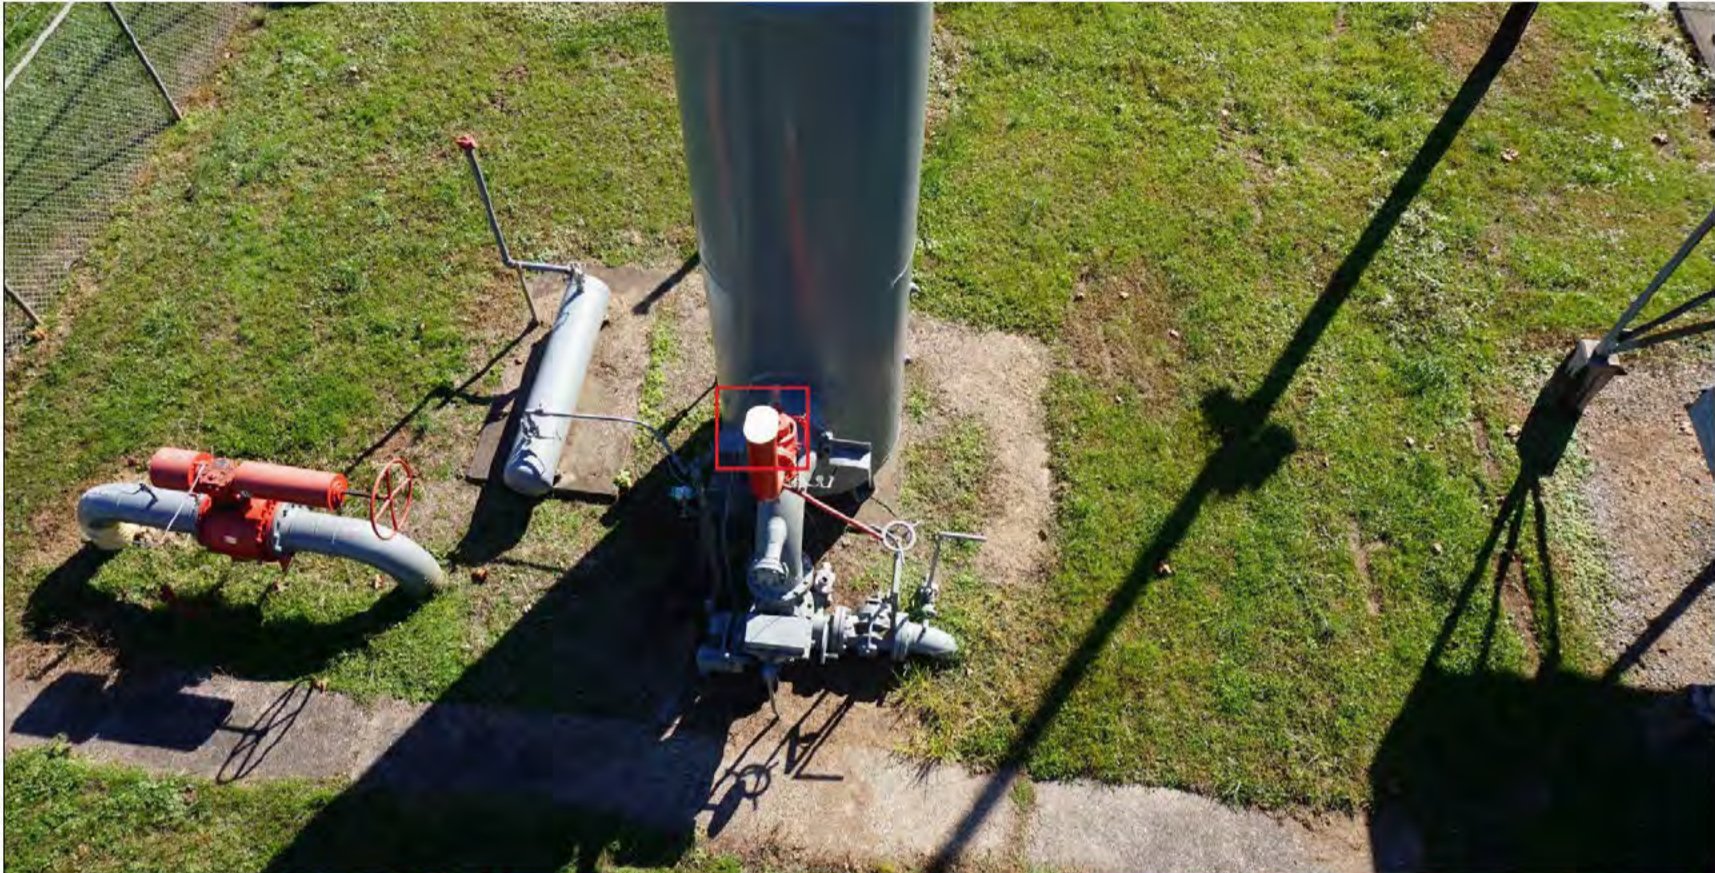
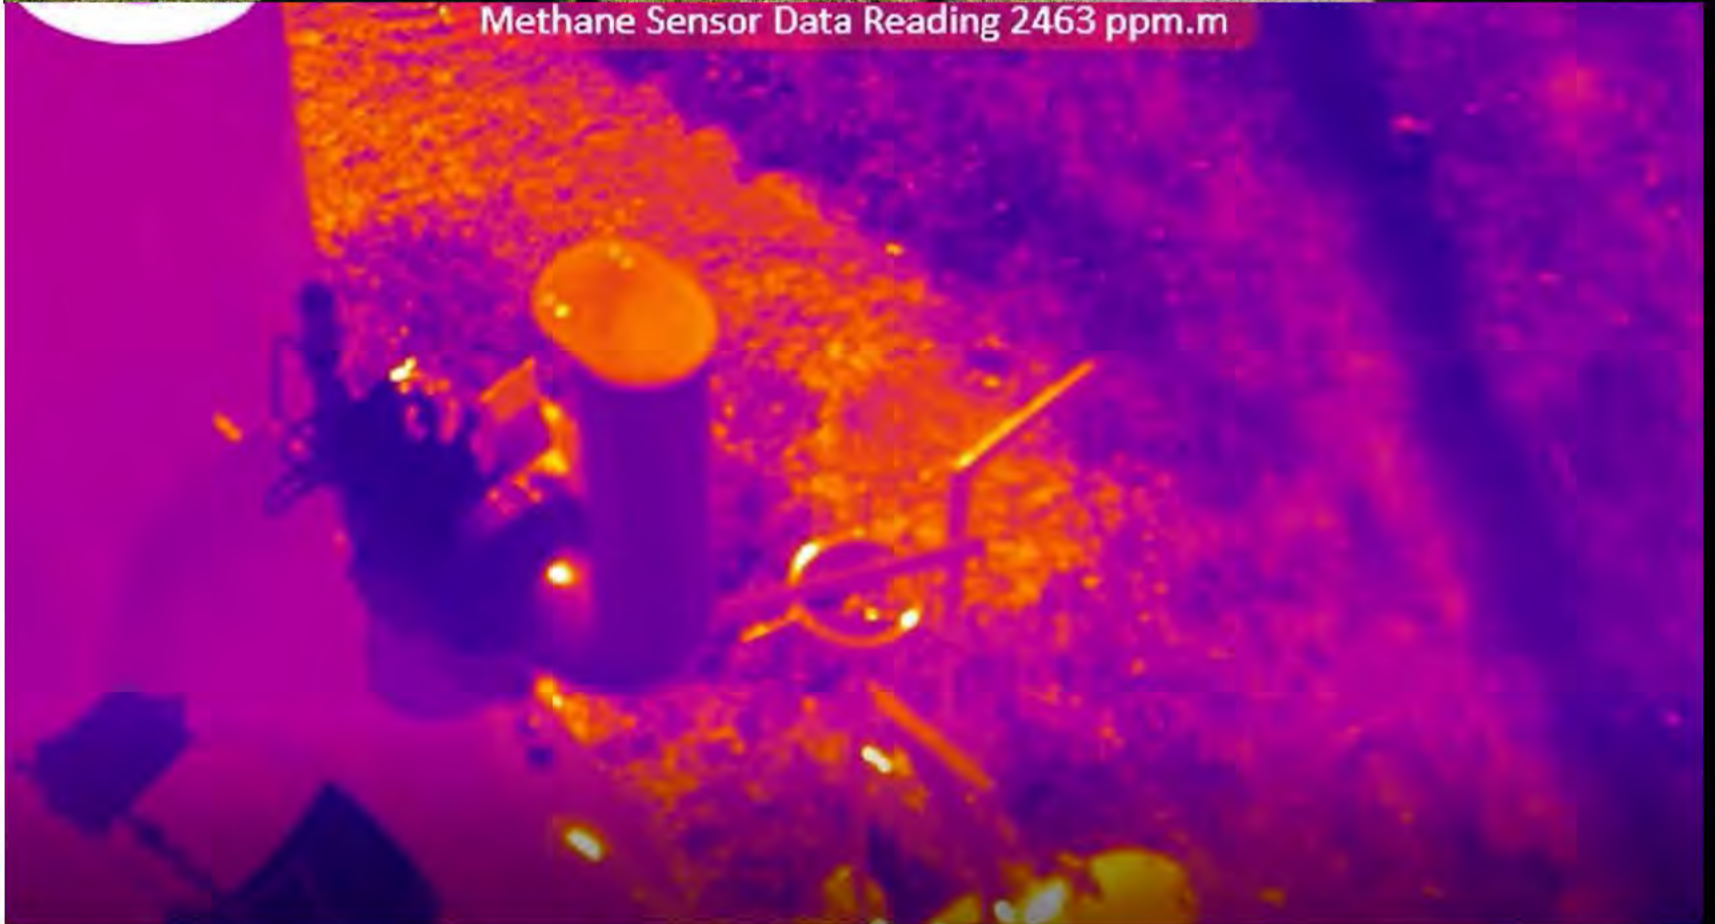
**Station Leak 2**

Time	Date	Location/GPS	Peak Reading (ppm.m)	Anomaly Type	Severity
11:33AM	11/07/2021	[REDACTED]	5432	Leak	Medium

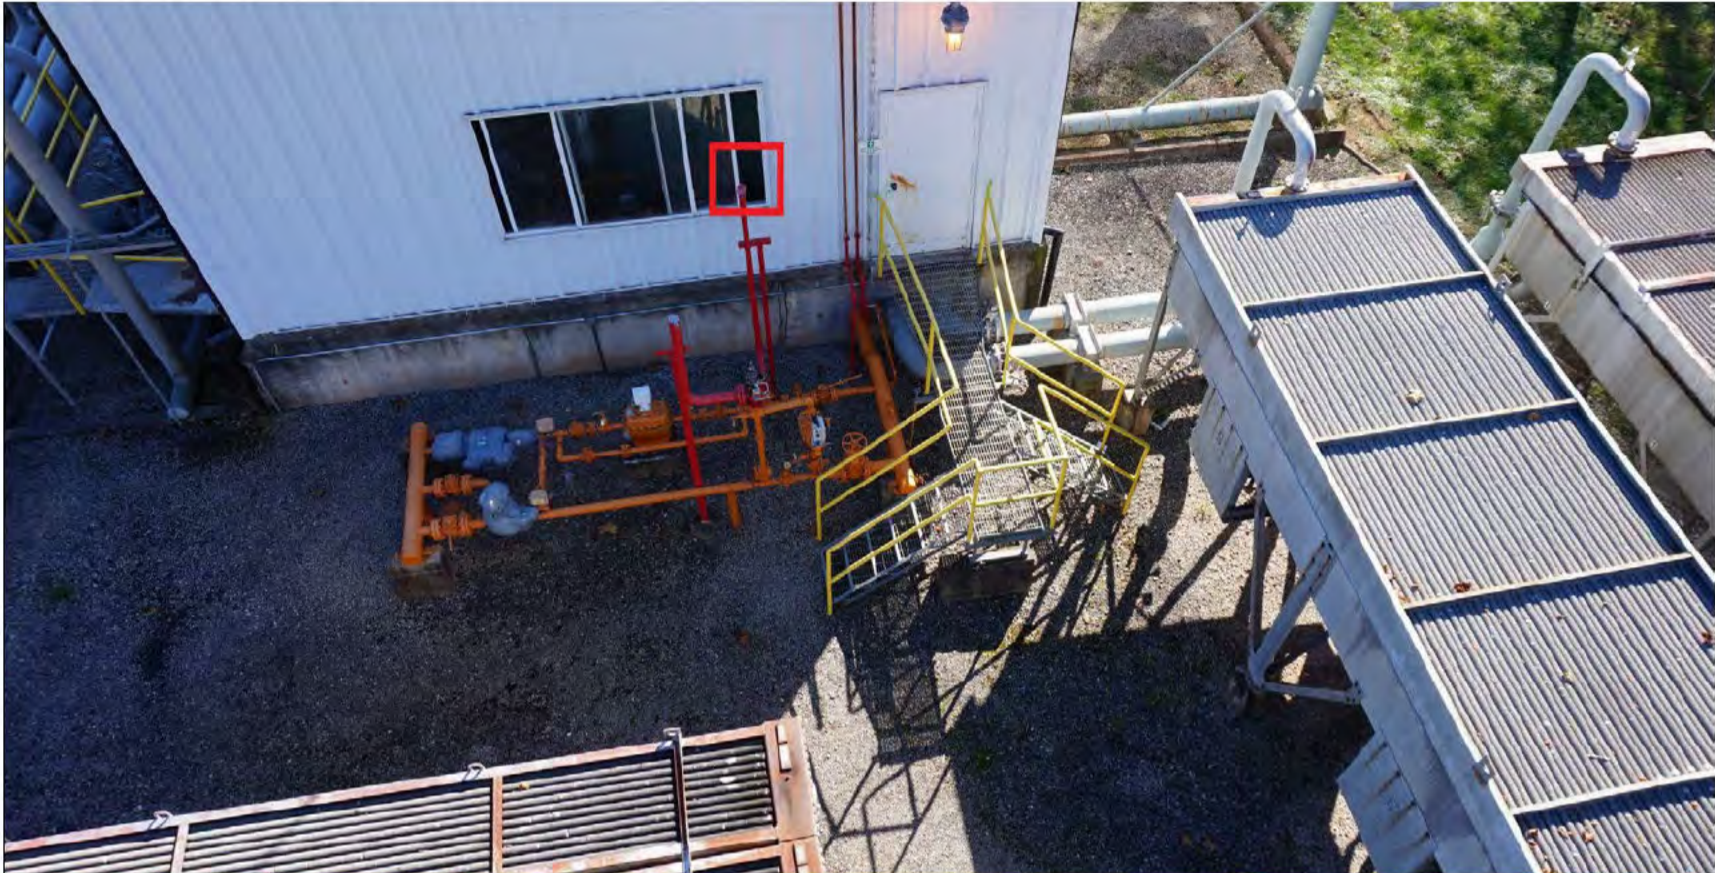
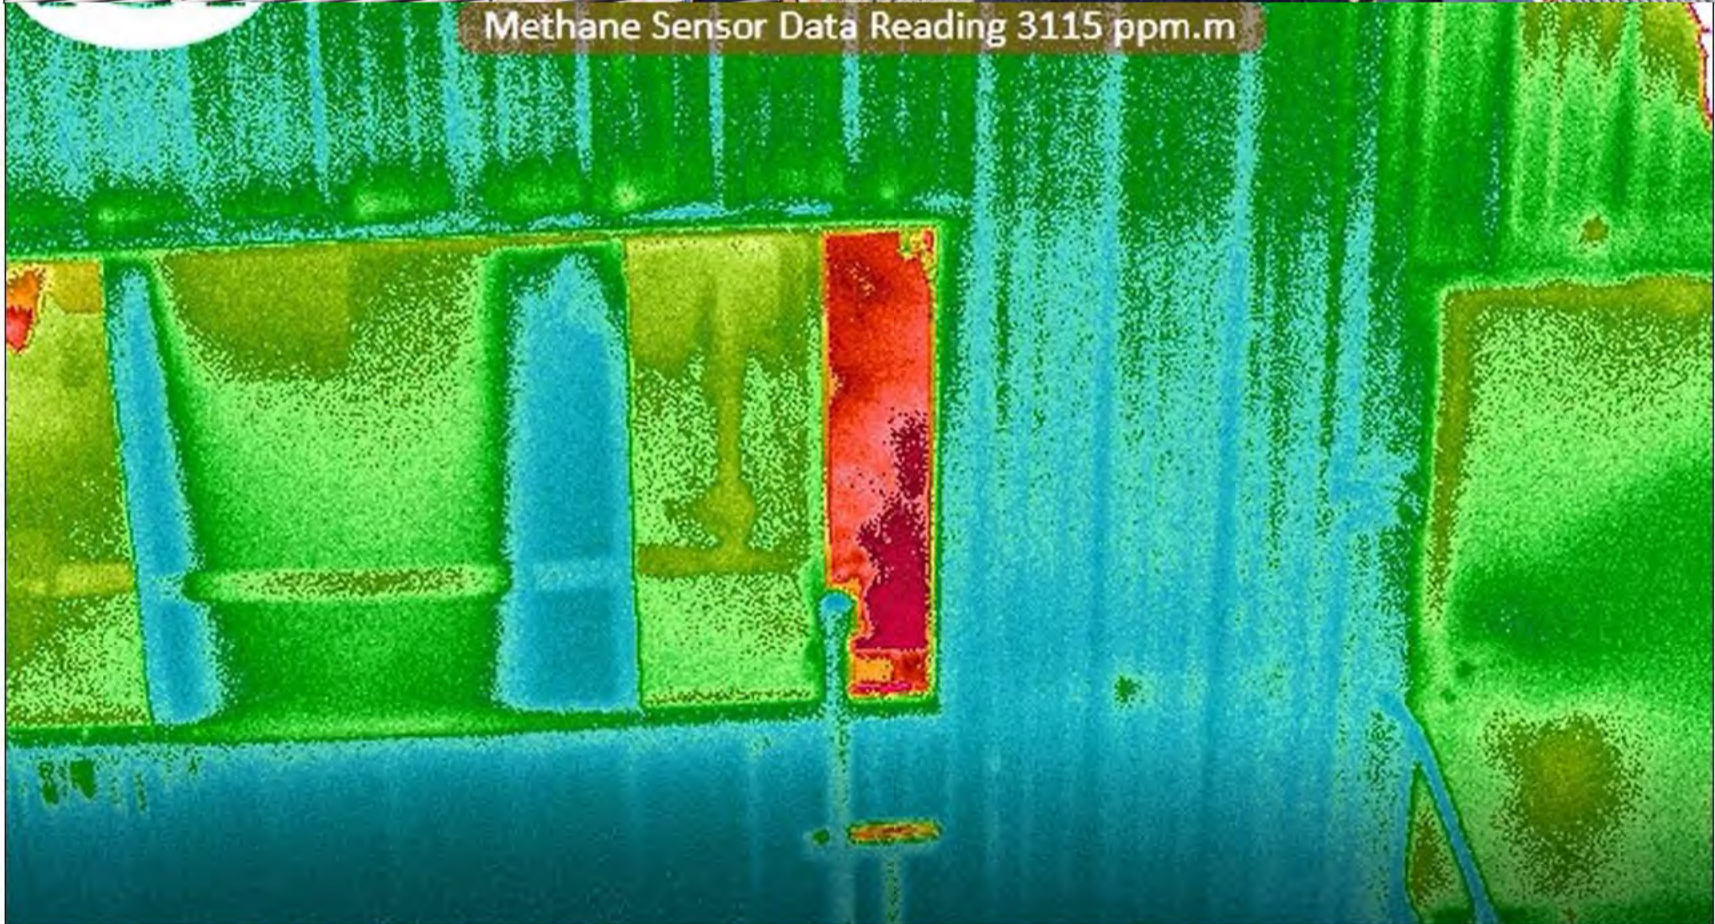
**Station Leak 3**

Time	Date	Location/GPS	Peak Reading (ppm.m)	Anomaly Type	Severity
12:00PM	11/07/2021	[REDACTED]	3115	Leak	Medium

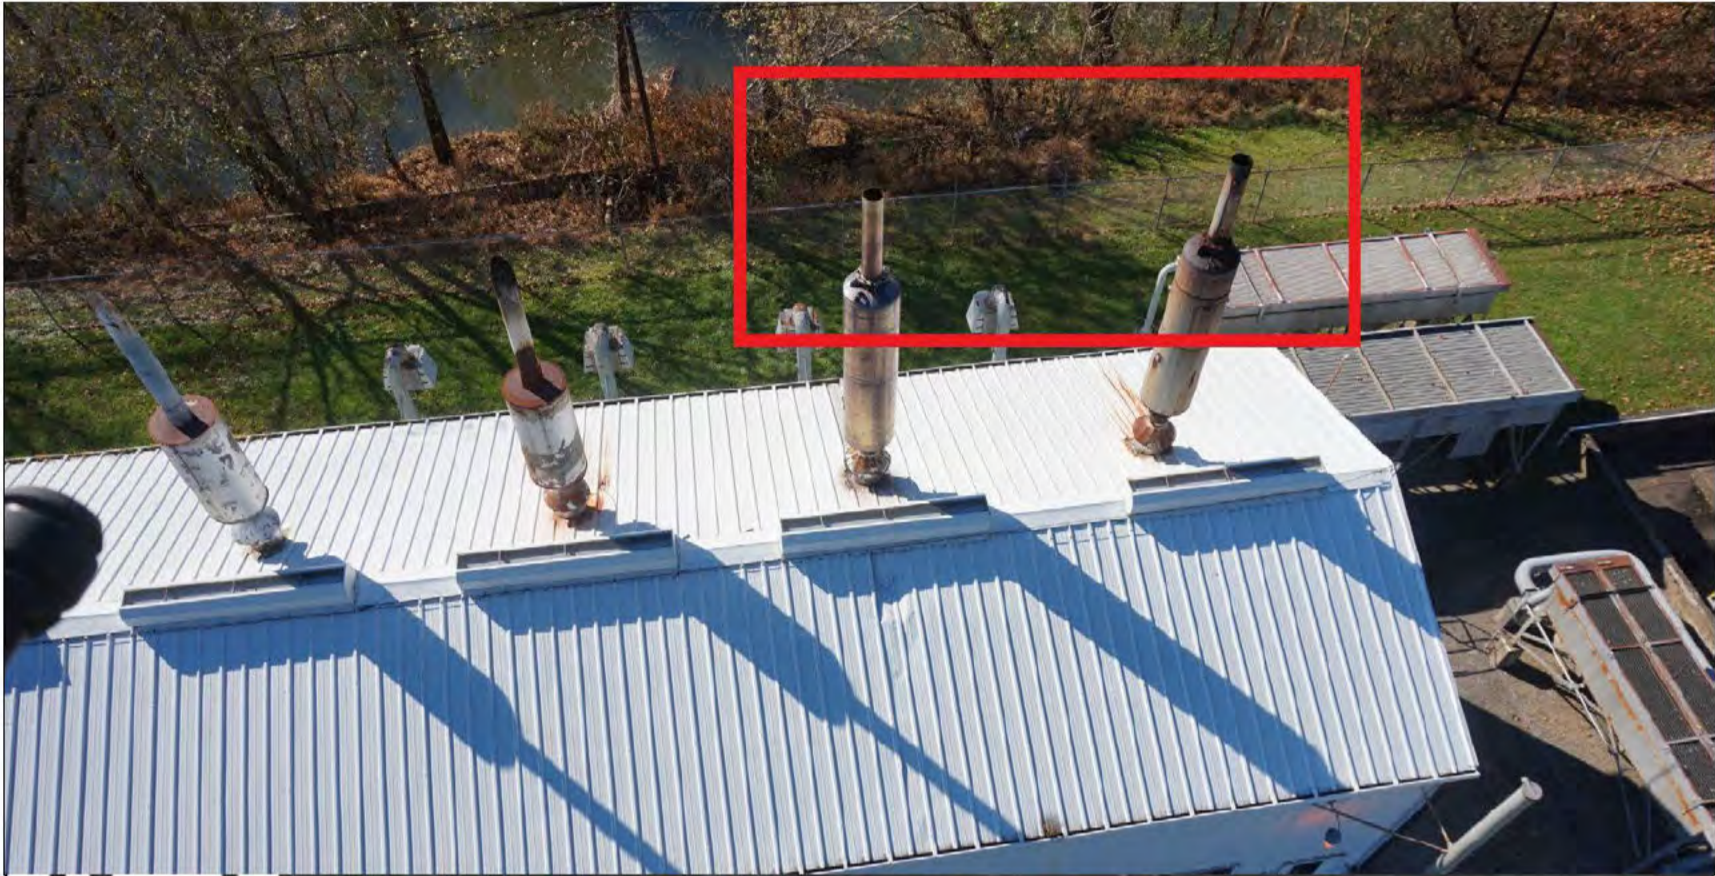
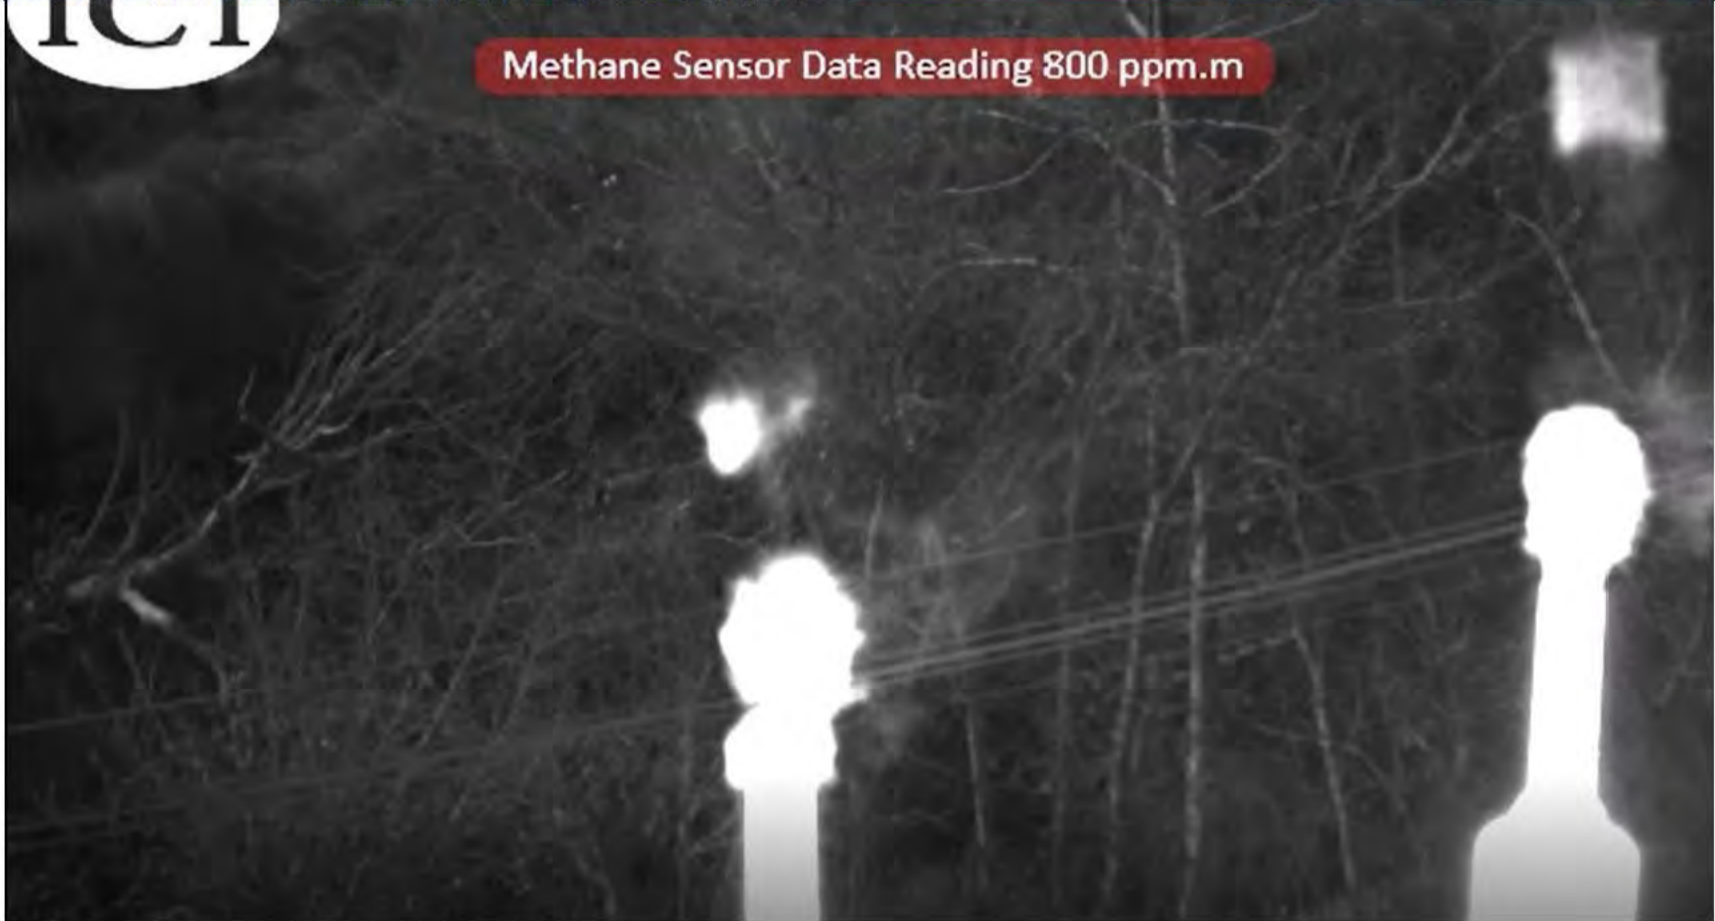
**Station Leak 4**

Time	Date	Location/GPS	Peak Reading (ppm.m)	Anomaly Type	Severity
12:27PM	11/07/2021	[REDACTED]	800	Leak	Low

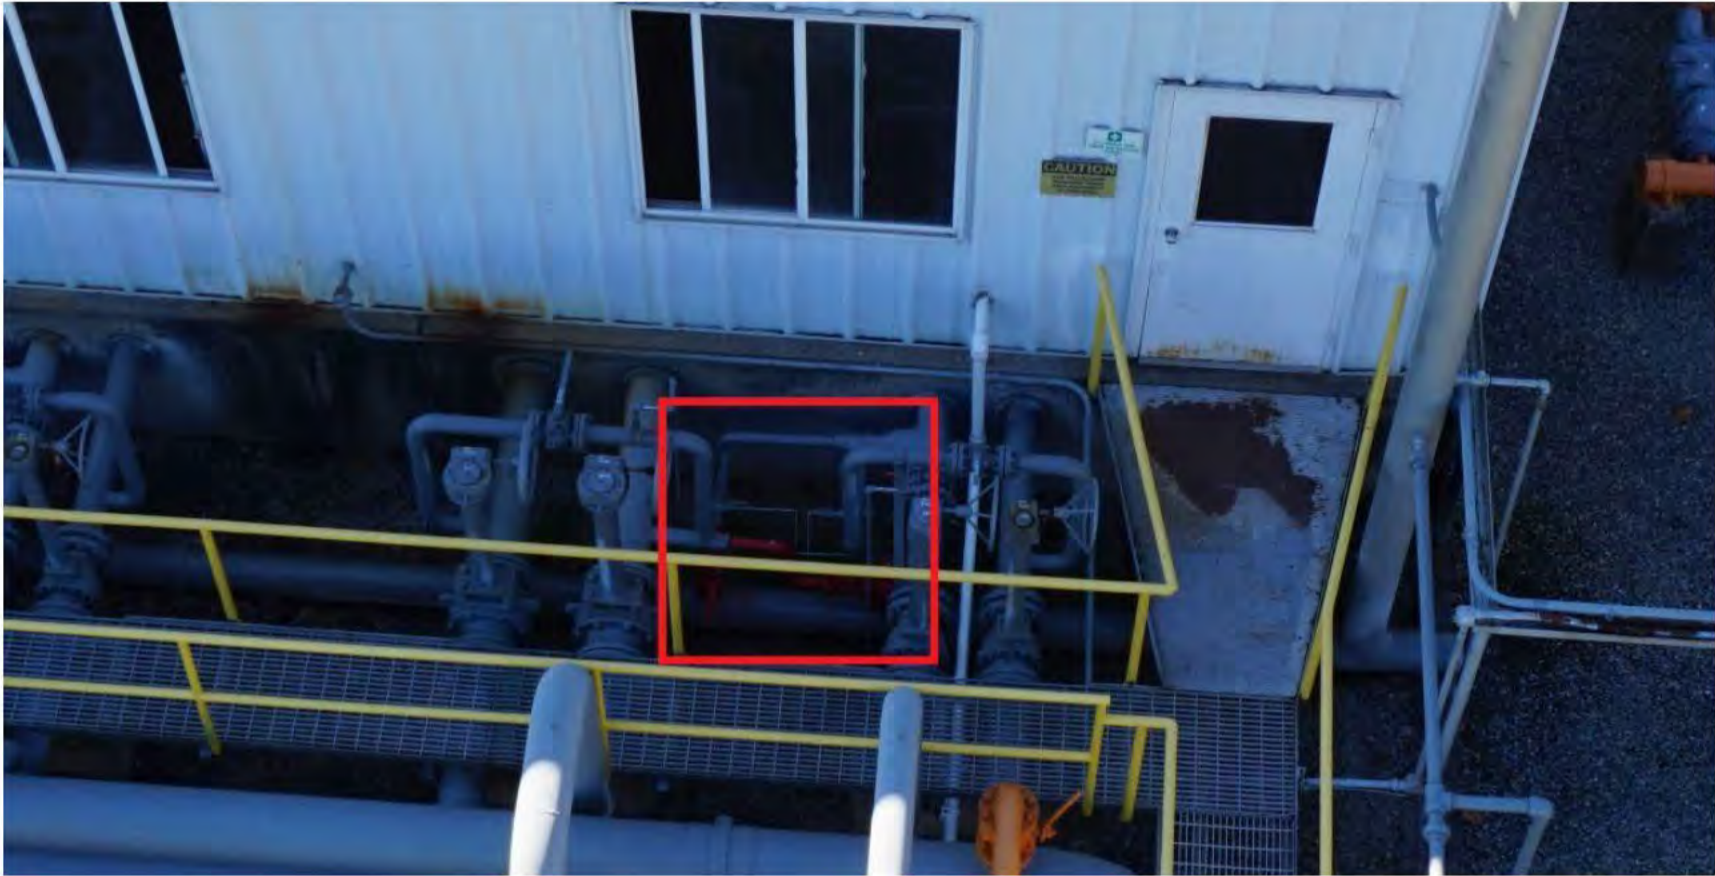
**Station Leak 5**

**No OGI Picture as Ground Scan Needs to be Completed**

Time	Date	Location/GPS	Peak Reading (ppm.m)	Anomaly Type	Severity
11:42AM	11/07/2021	[REDACTED]	40	Leak	Low

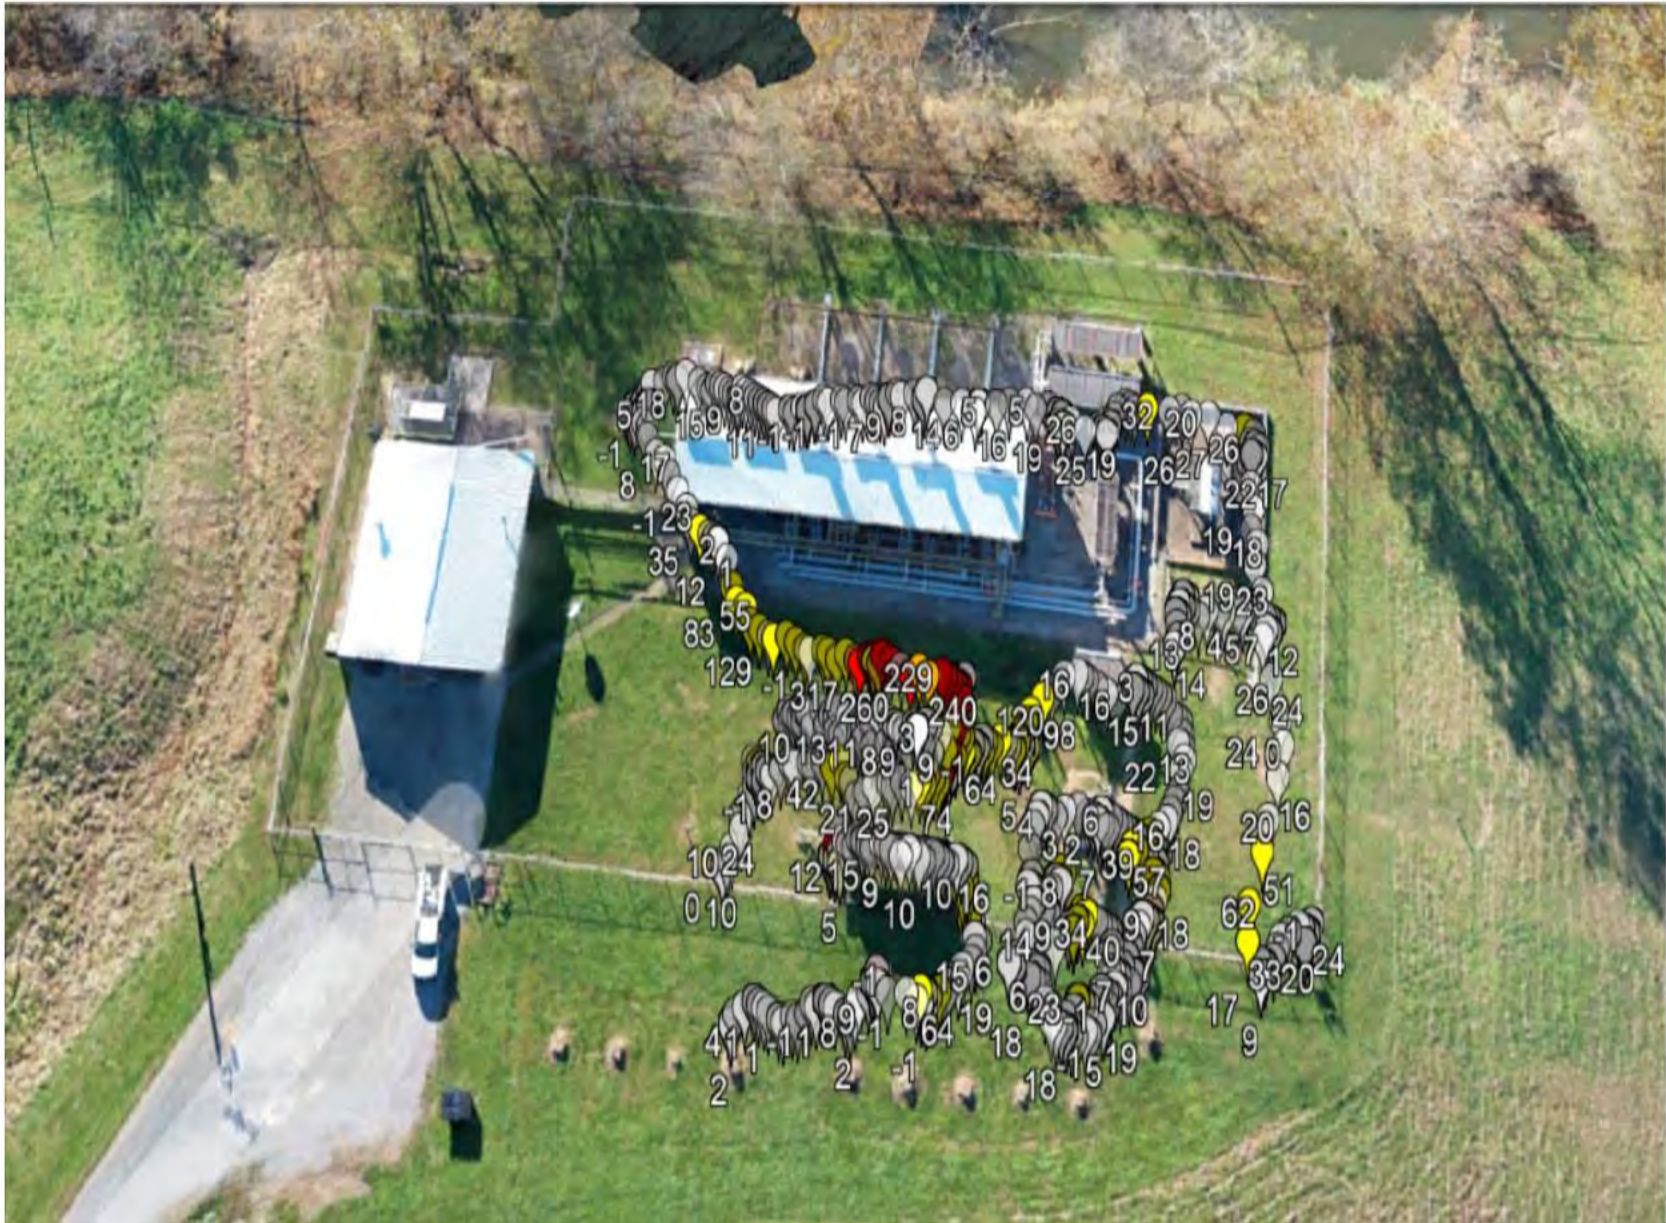
## Compressor Station Crew Flight Readings

Notes: Flight path covered all visible exterior equipment. The readings above are shown from the location of the UAV at time of recording ( every .80 Seconds ) and are not indicative of the location of the leak. The UAV with sensor stands off from the equipment on average of 15-20 meters. See Leak information for data that corresponds to each leak.

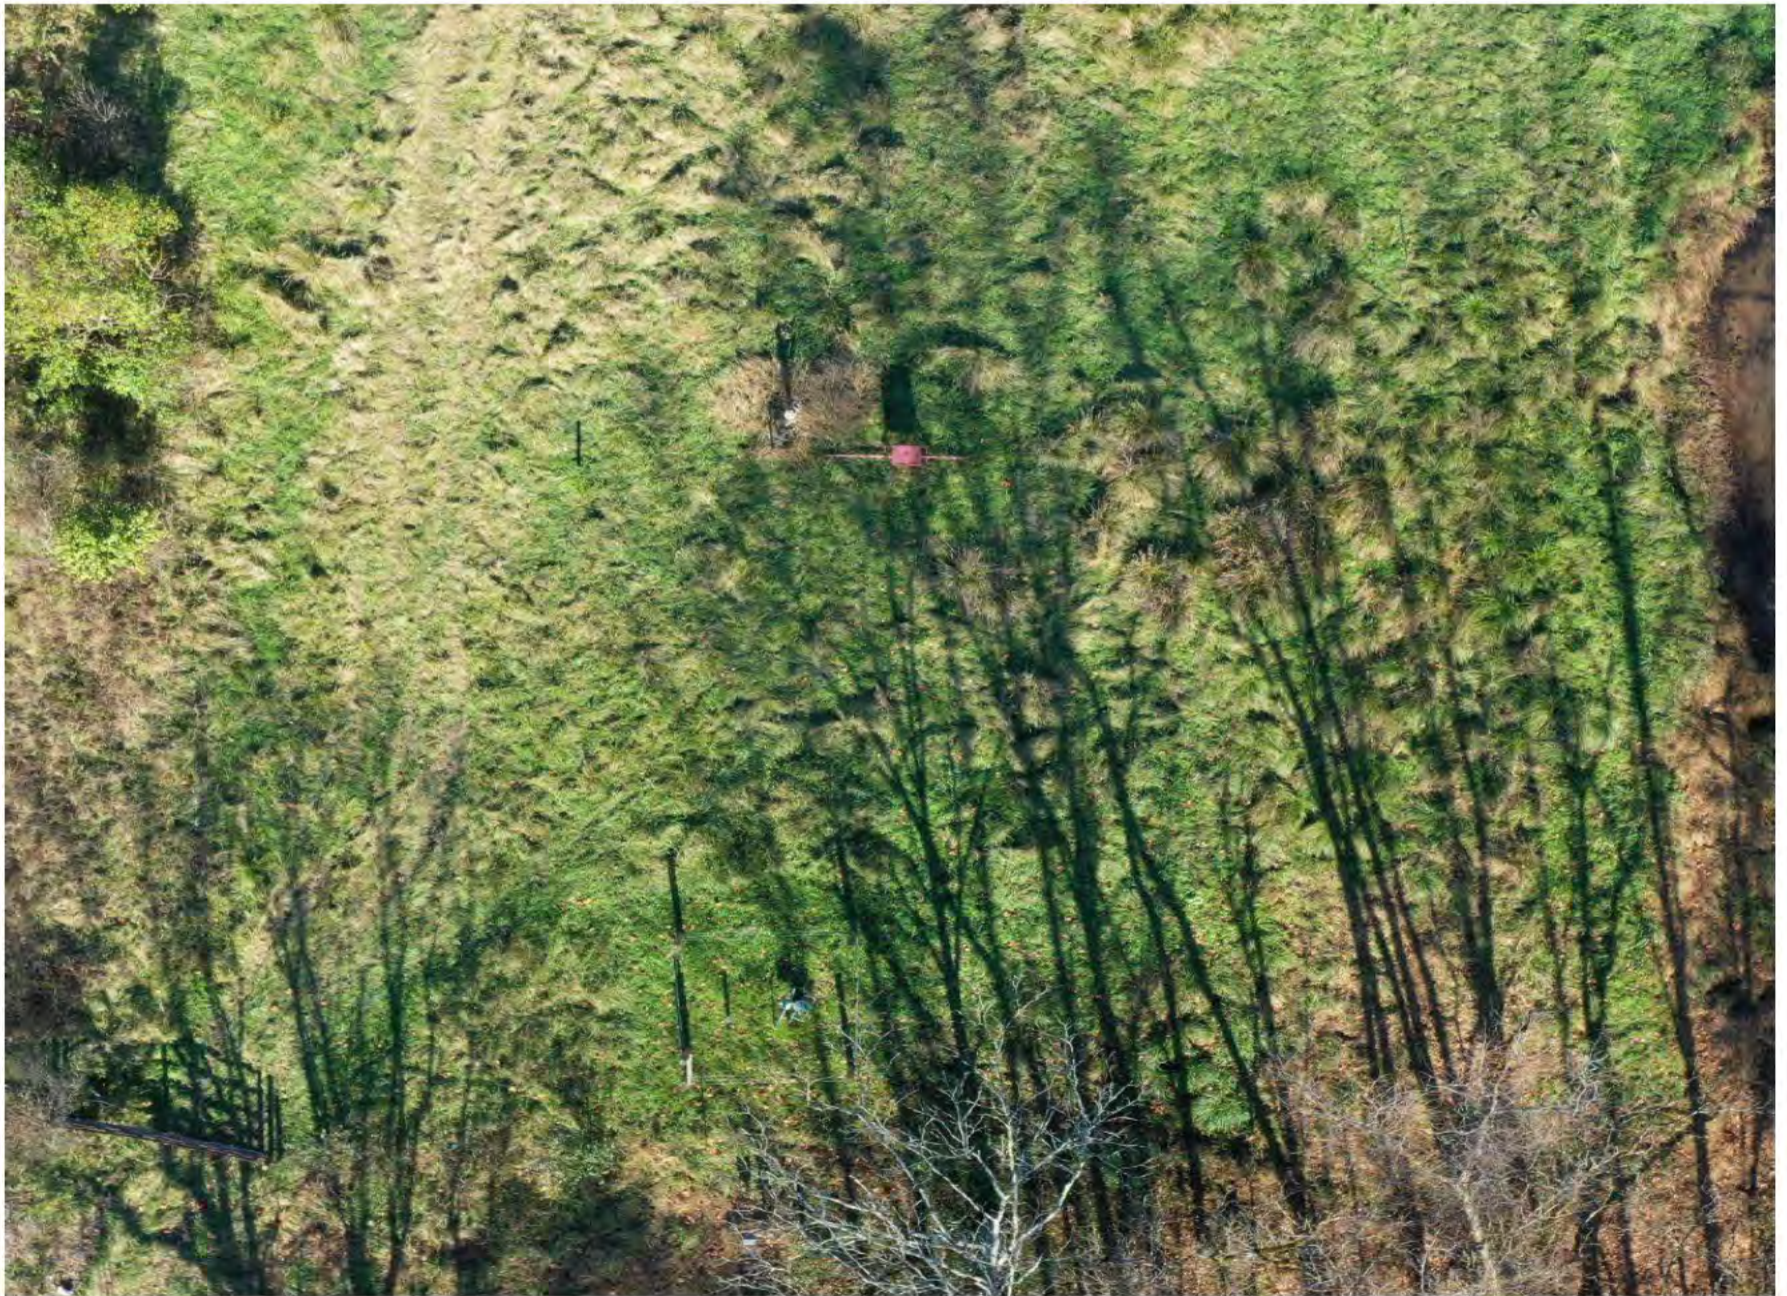
Time	Date	Location/GPS	Peak Reading (ppm.m)	Anomaly Type	Severity
3:15PM	11/06/2021	[REDACTED]	2332	Leak	Medium

Leak 1: Pipe Thread.. Consistent readings. Averaging approximately 500 ppm.m.
