## SURVEY REPORT

## OVERVIEW

Aerial Production Services performed an Aerial Gas Leak Survey of [REDACTED] Compressor Station and 3 Well Site Locations Outlined in the Report. The Gas Leak Survey identified 9 Total Methane Leaks. See Report Below for additional Details.

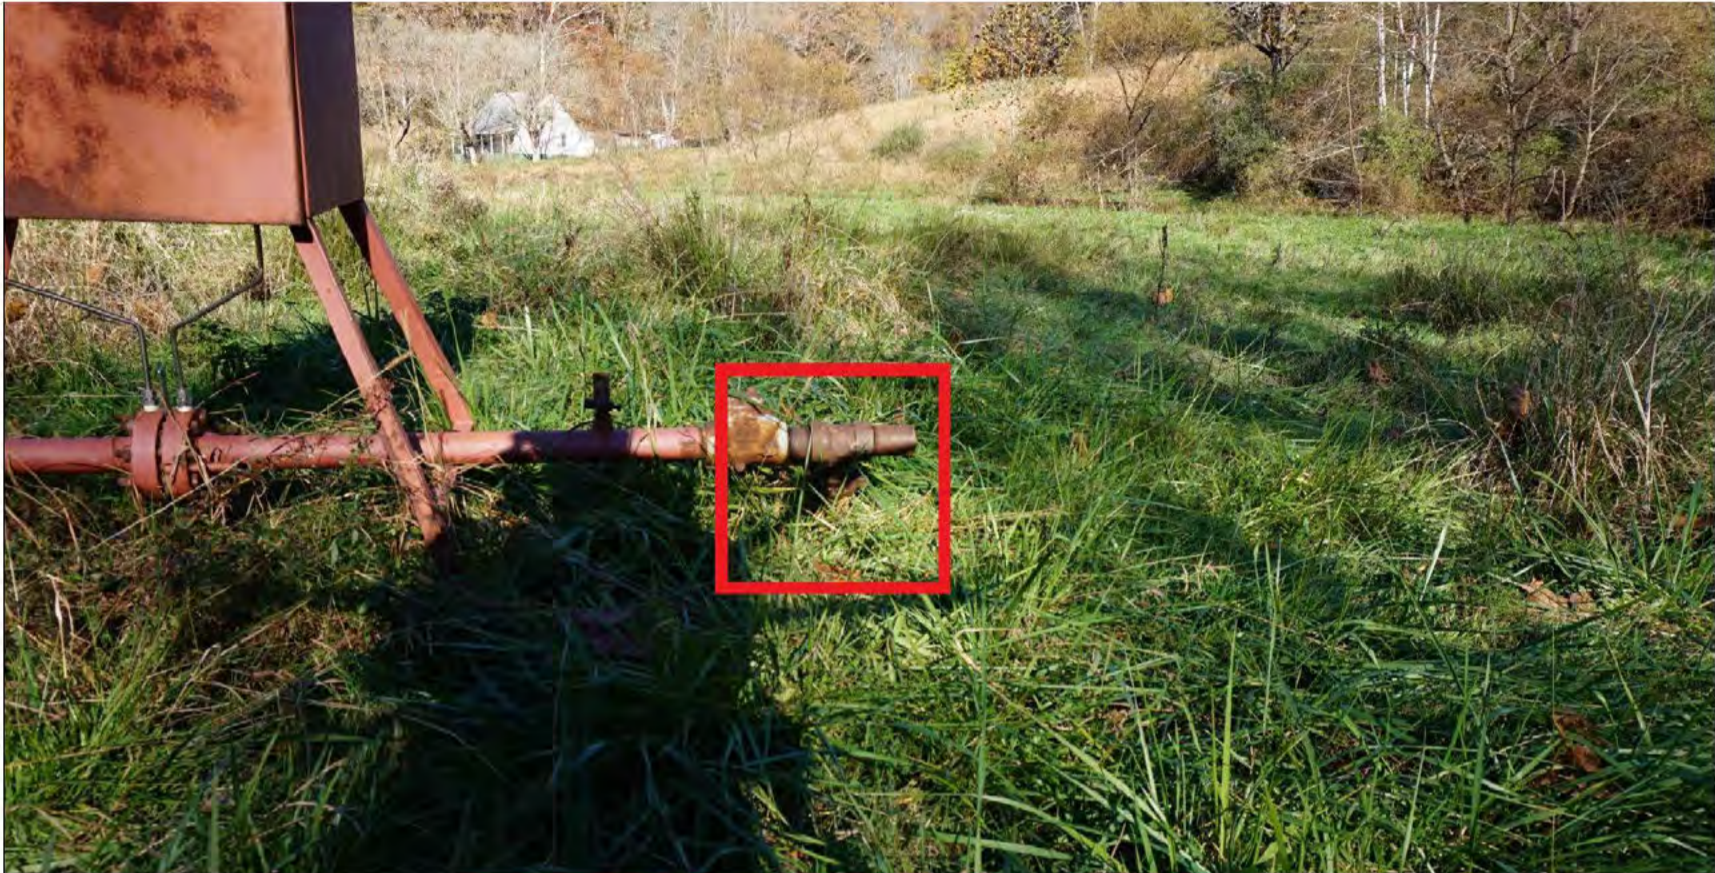
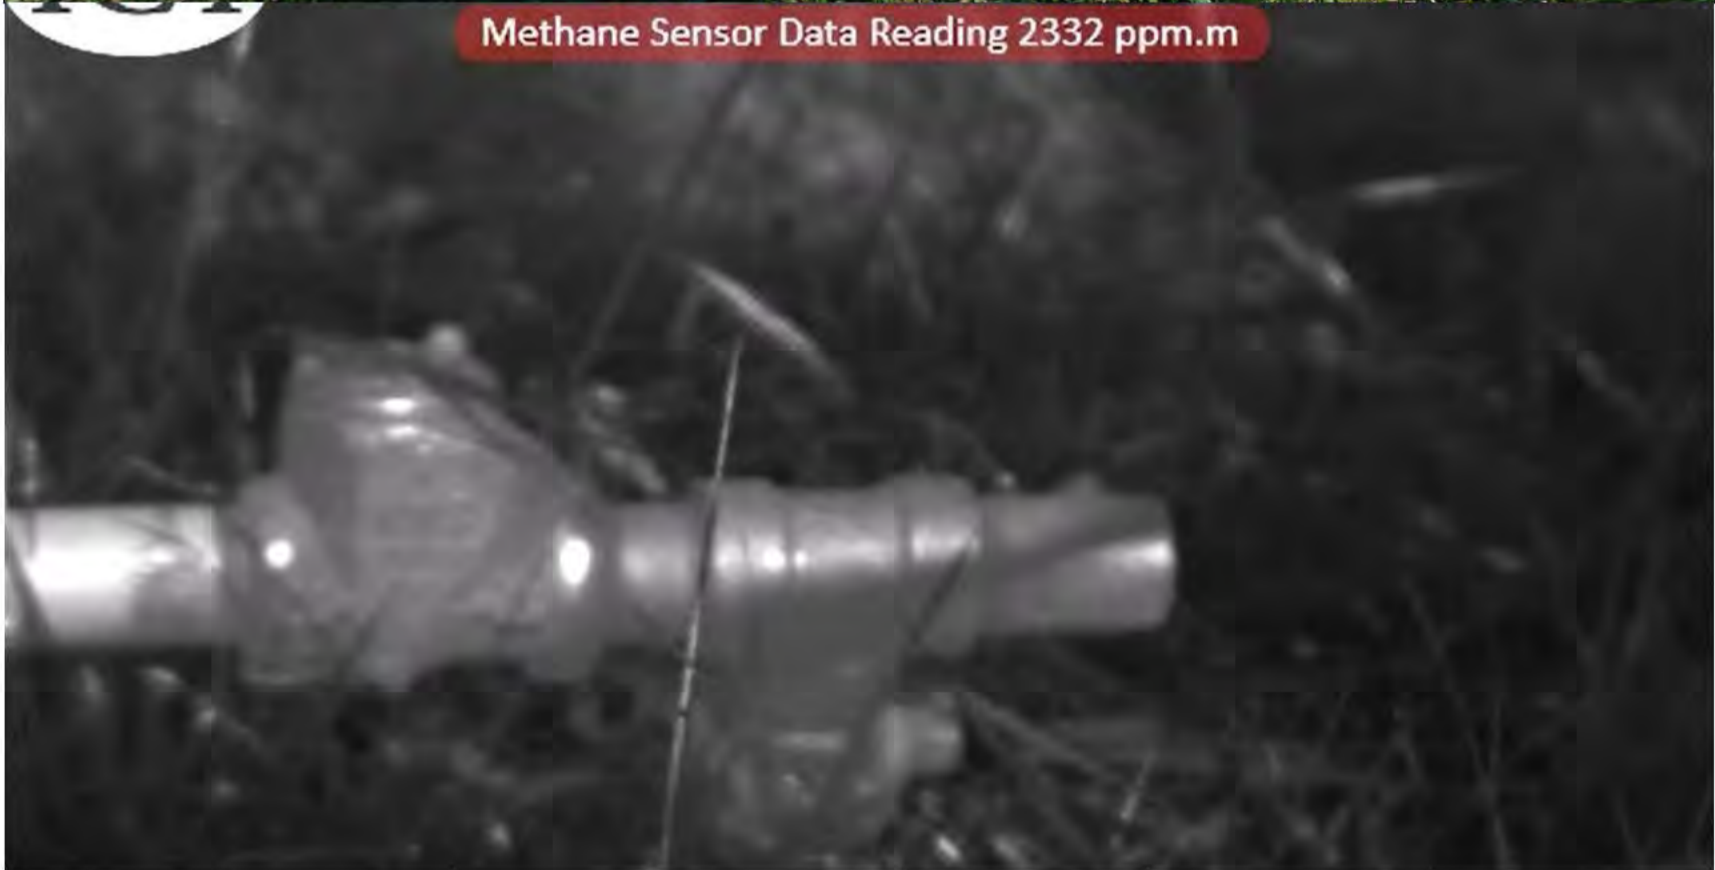
## Leak 1

Methane Sensor Data Reading 2332 ppm.m

Time	Date	Location/GPS	Peak Reading (ppm.m)	Anomaly Type	Severity
3:15PM	11/06/2021	[REDACTED]	2332	Leak	Medium

Leak 1: Pipe Thread.. Consistent readings. Averaging approximately 500 ppm.m.

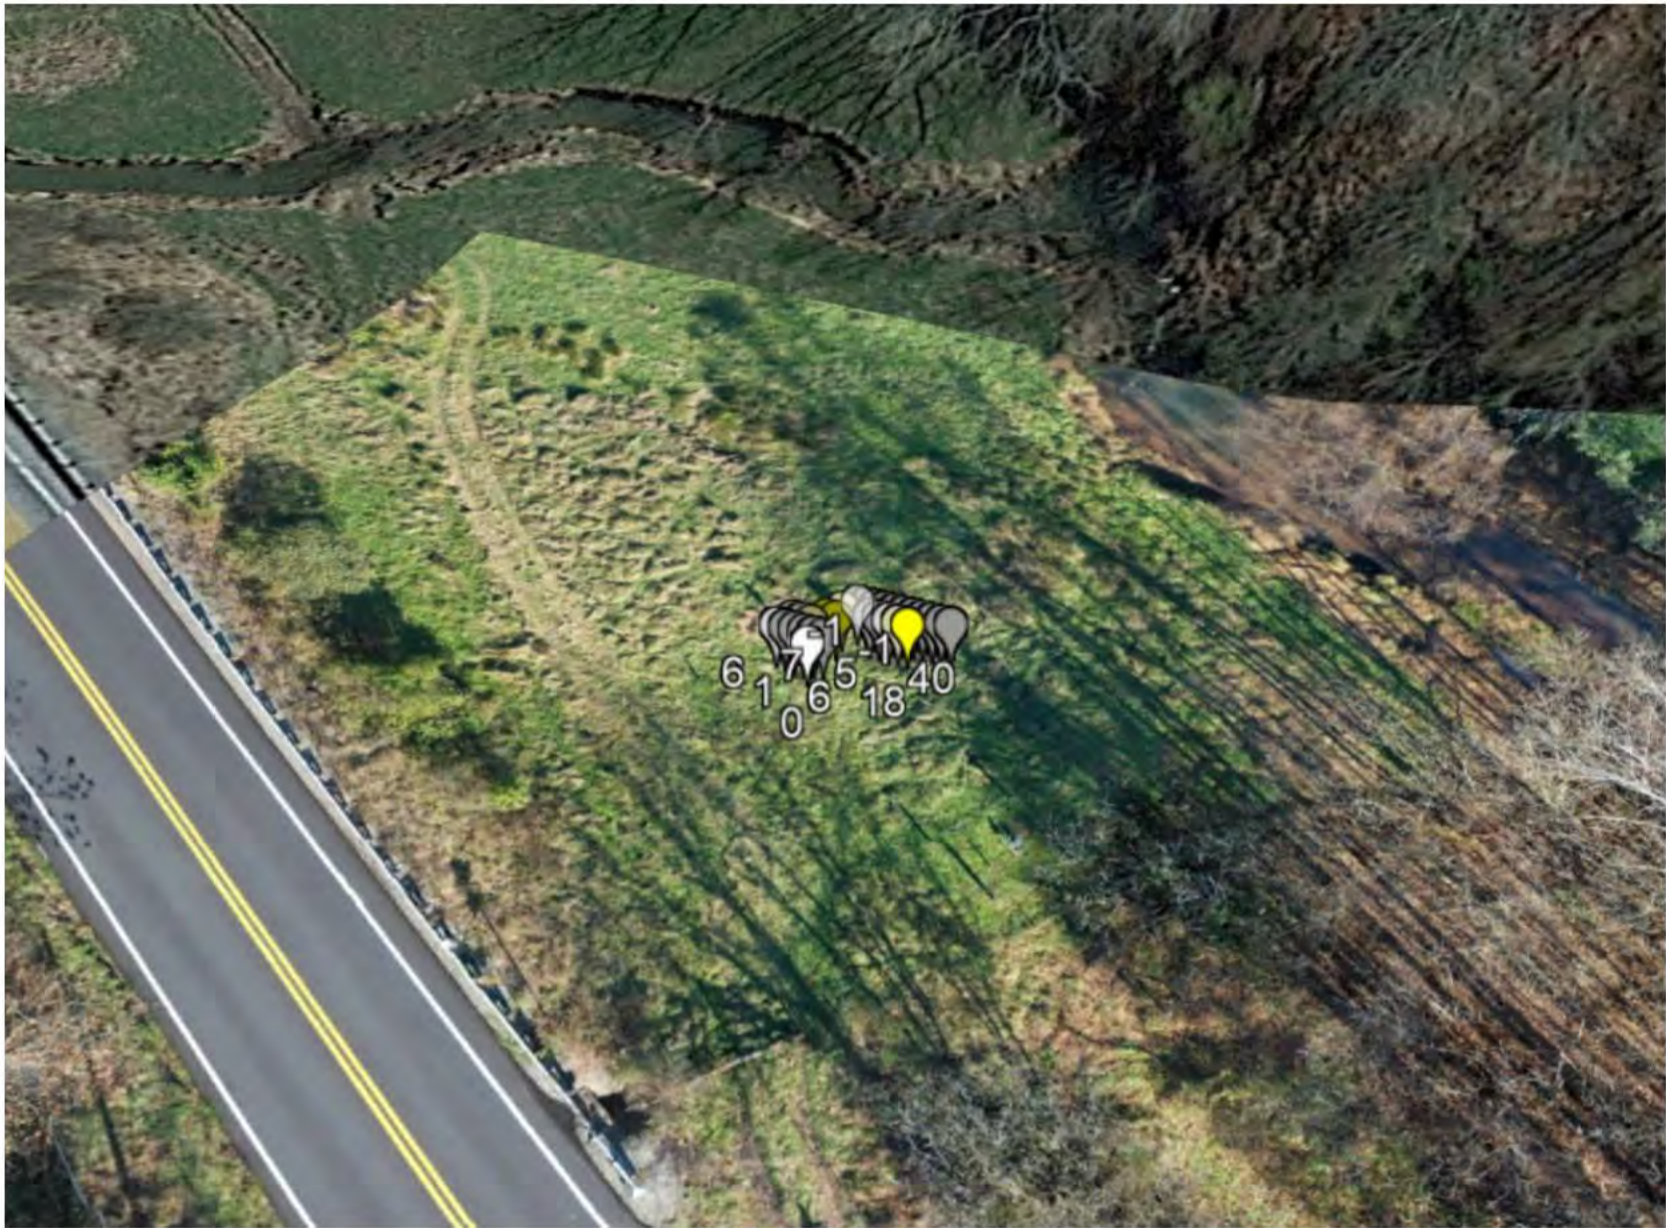
## Crew Flight Readings

Notes: Flight path covered all visible exterior equipment. The readings above are shown from the location of the UAV at time of recording ( every .80 Seconds ) and are not indicative of the location of the leak. The UAV with sensor stands off from the equipment on average of 15-20 meters. See Leak information for data that corresponds to each leak.

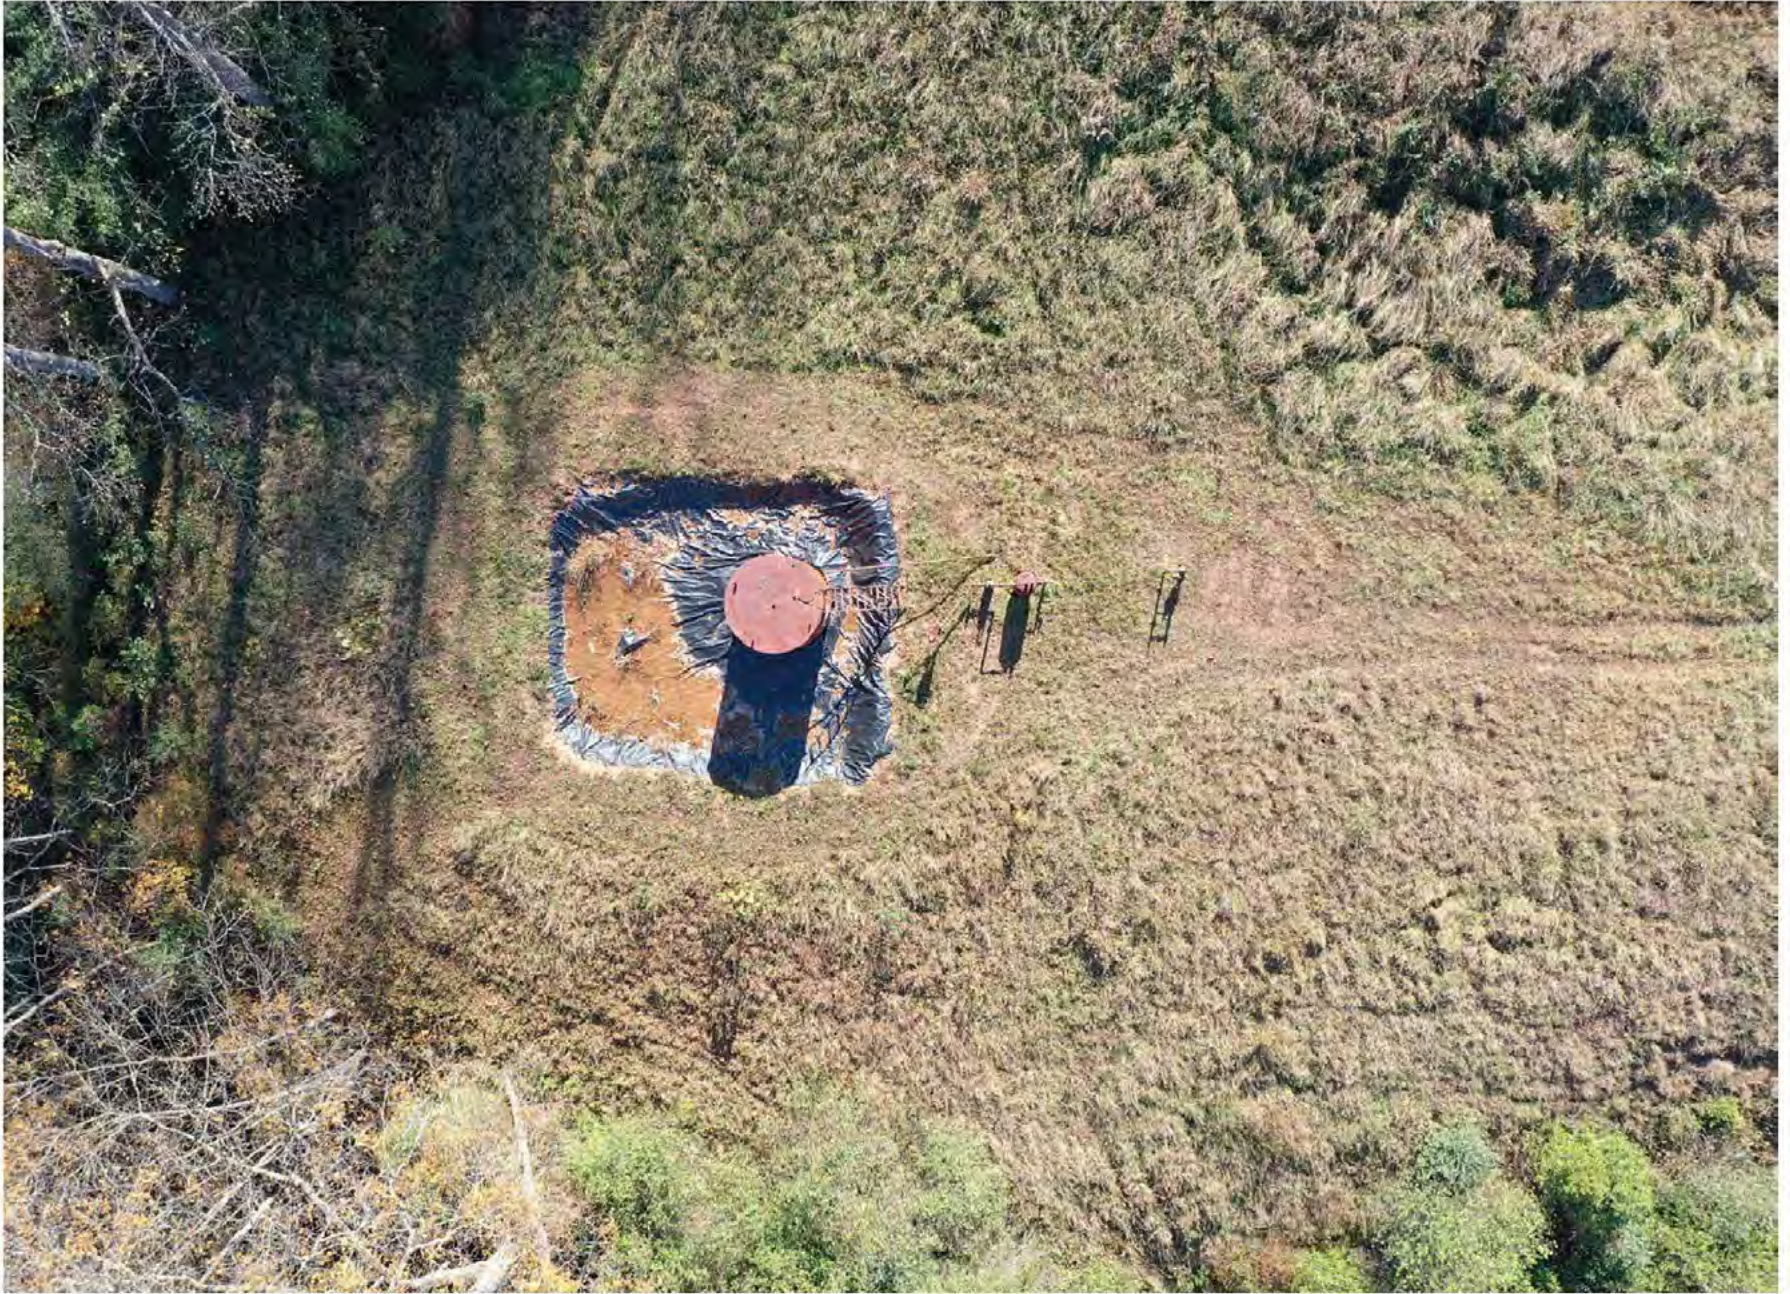
## Well Site Overview

Time	Date	Location/GPS	Peak Reading (ppm.m)	Anomaly Type	Severity
1:55PM	11/08/2021	[REDACTED]	183	Leak	Low

Time	Date	Location/GPS	Peak Reading (ppm.m)	Anomaly Type	Severity
2:06PM	11/08/2021	[REDACTED]	186	Leak	Low

Time	Date	Location/GPS	Peak Reading (ppm.m)	Anomaly Type	Severity
2:17PM	11/08/2021	[REDACTED]	81	Leak	Low

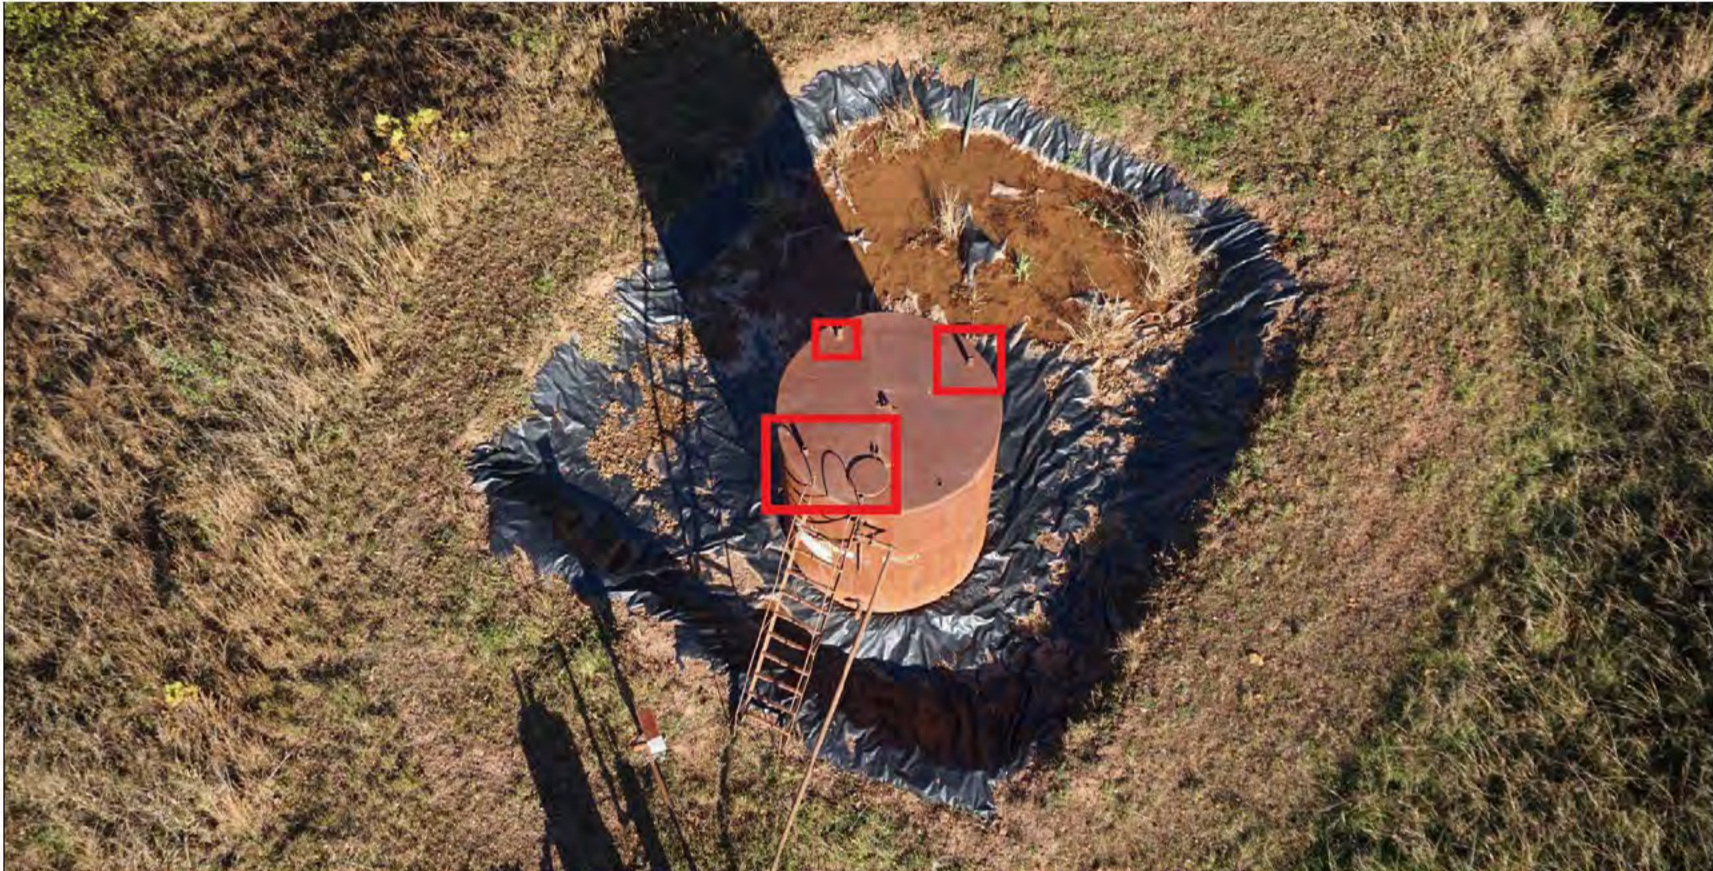
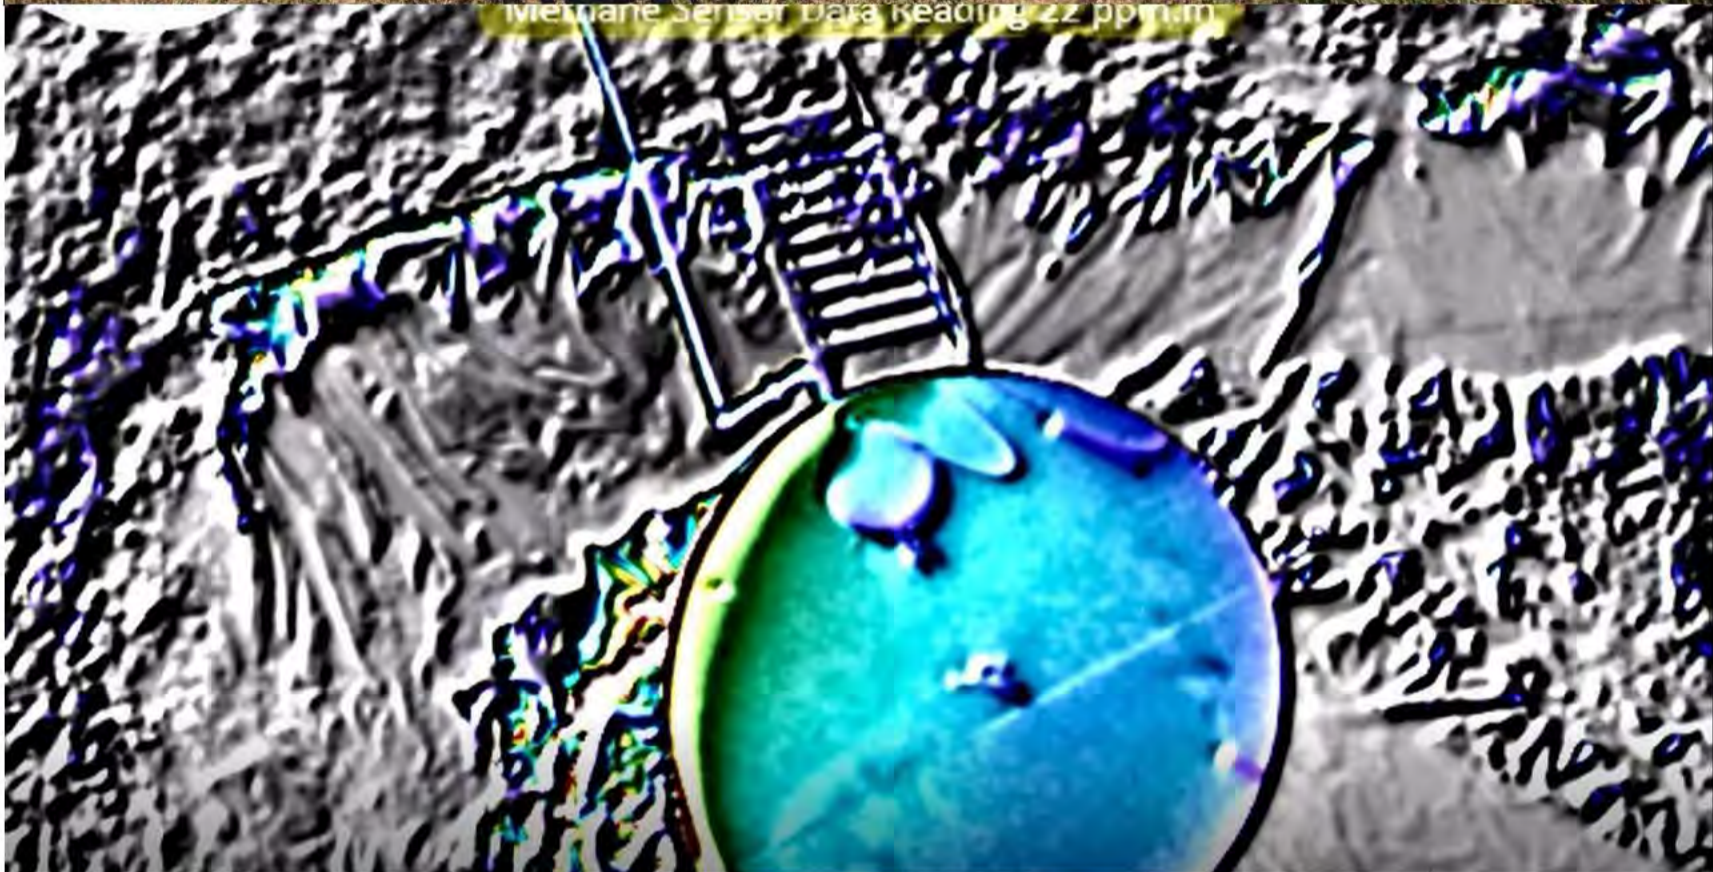
**Leak 1**

Leak 1: Tank Vents.. Consistent readings. Averaging approximately 65 ppm.m.  
Leak 2: WellHead Thread. Intermittent Leak. Small Average below 50 ppm.m  
Leak 3: Unknown Equipement Leak. Continuous Leak. Average 35 ppm.m

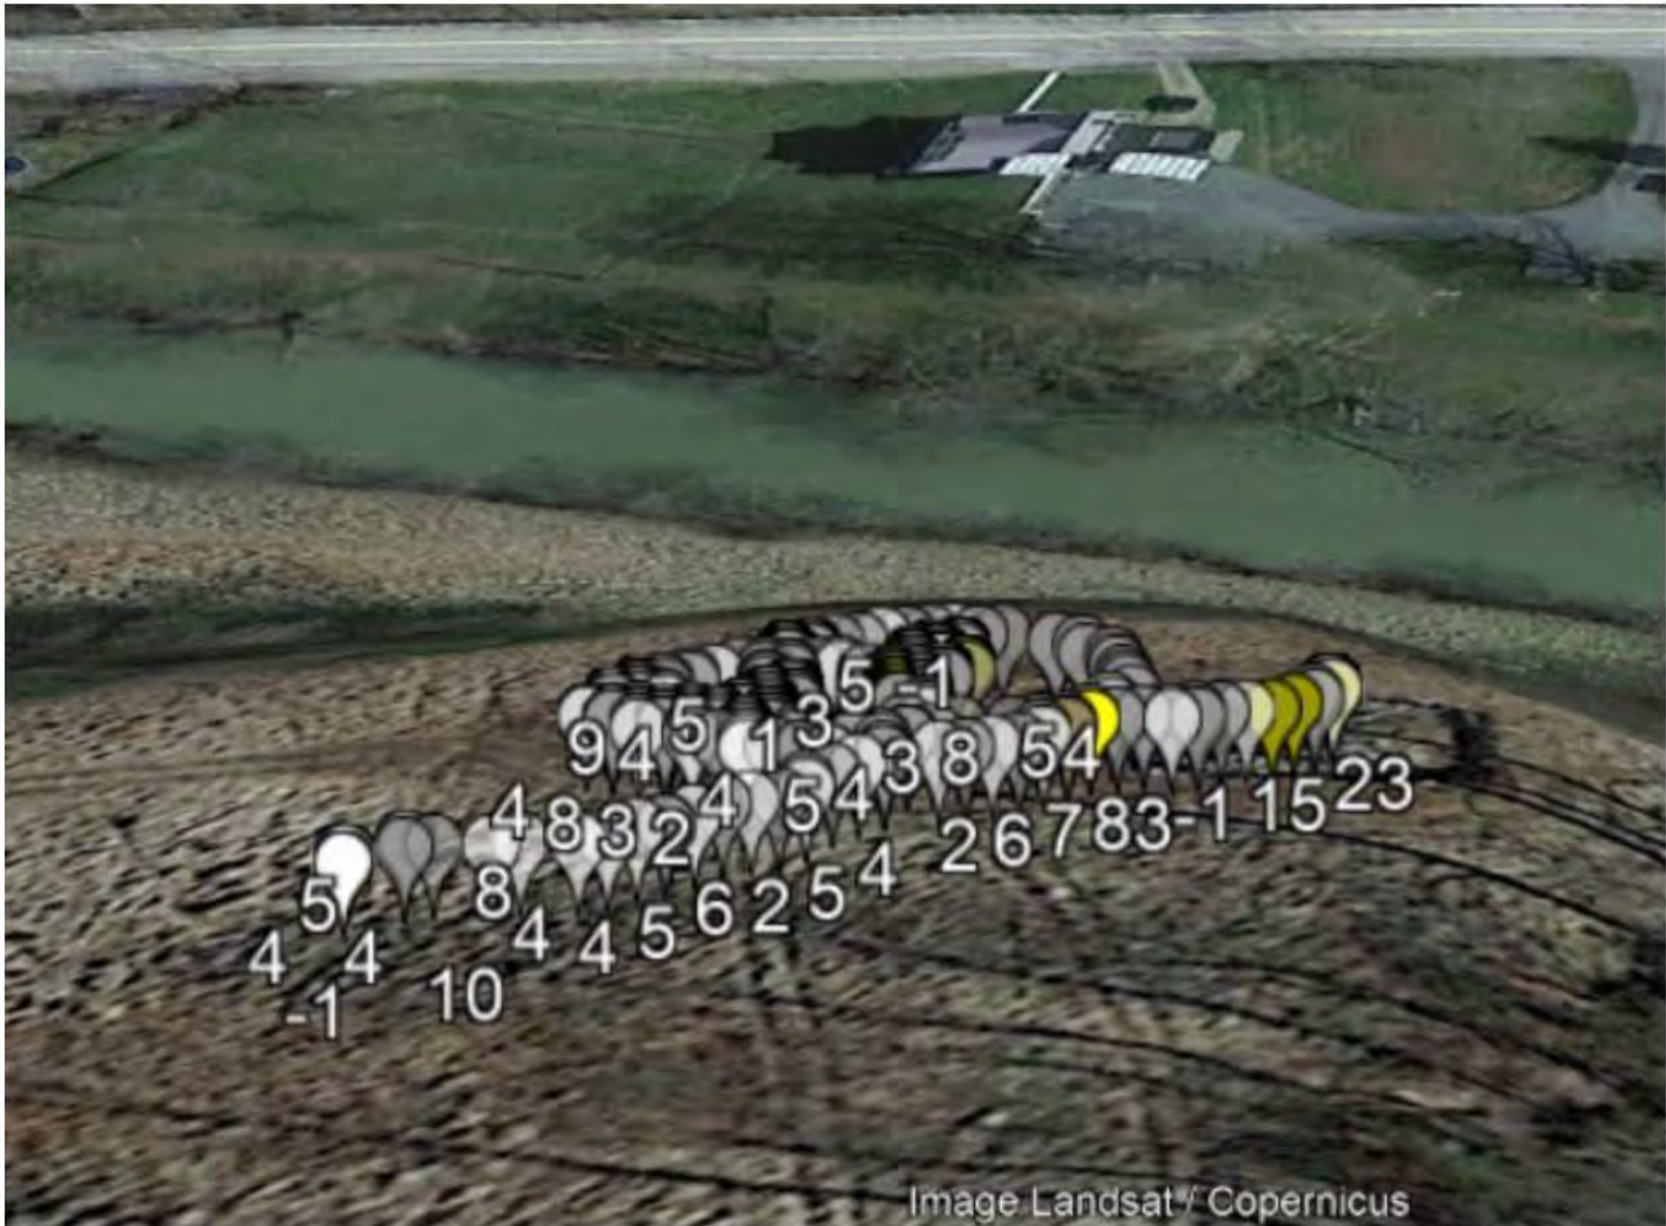
## ██████████ Crew Flight Readings

Notes: Flight path covered all visible exterior equipment. The readings above are shown from the location of the UAV at time of recording ( every .80 Seconds ) and are not indicative of the location of the leak. The UAV with sensor stands off from the equipment on average of 15-20 meters. See Leak information for data that corresponds to each leak.
